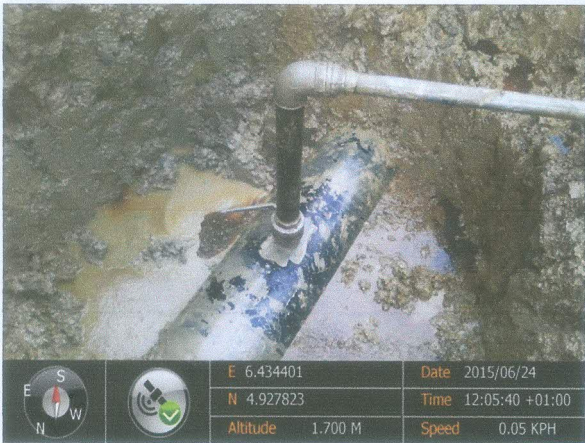
Fig1 Incident Point

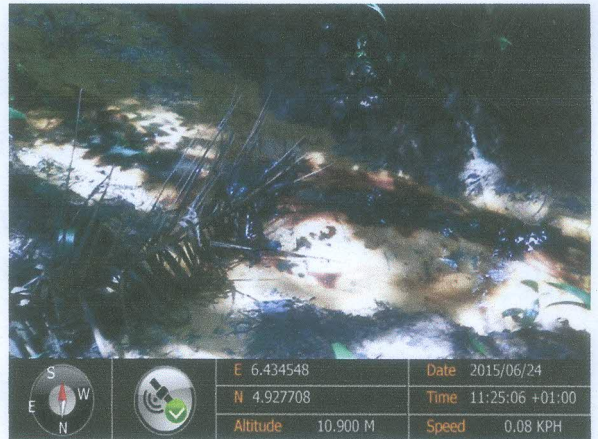
Fig 2 Impacted Area

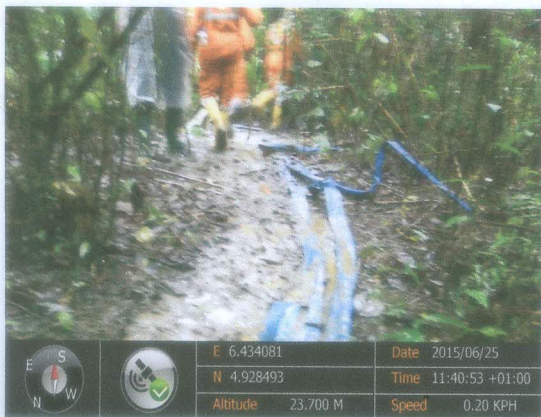
Fig 5 Materials used by the bunkers

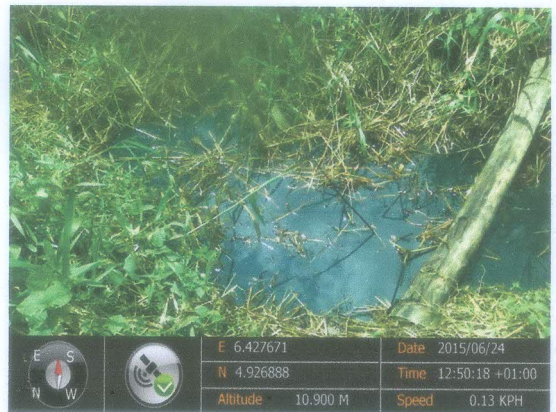
Fig 6 flowed spill to another community
