## 19. Photographs:

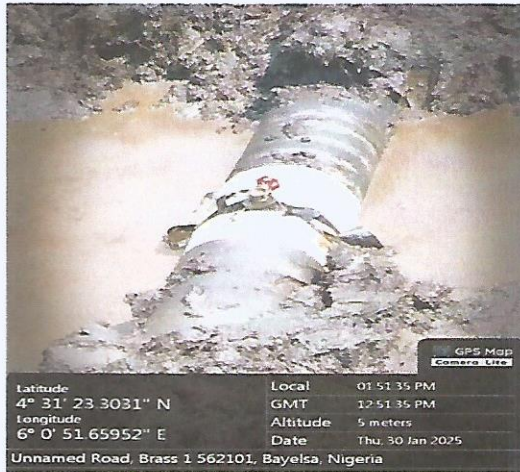
Fig 1. Incident point during initial assessment

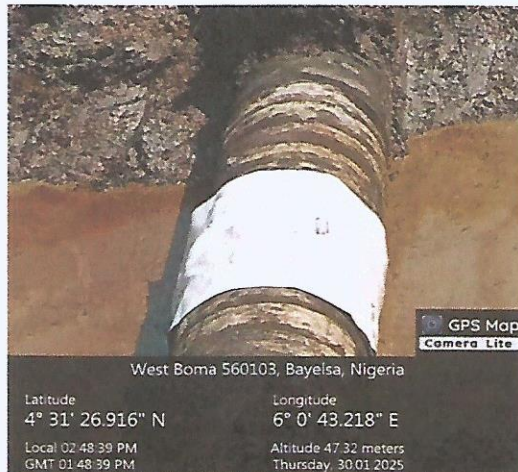
Fig 2. Incident point after repairs
