## 19. Photographs:

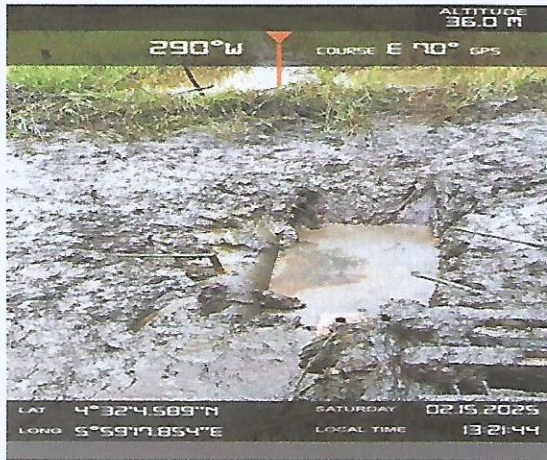
Fig 1. Incident point after exposing the pileline
