National Oil Spill Detection and Response Agency

JOINT INVESTIGATION VISIT (JIV) FORM

| Site Organization | | Mandatory Information Required | |
|---|---|---|---|
| Company Name | | NEPL | |
| Incident Number | | 2025/001 | |

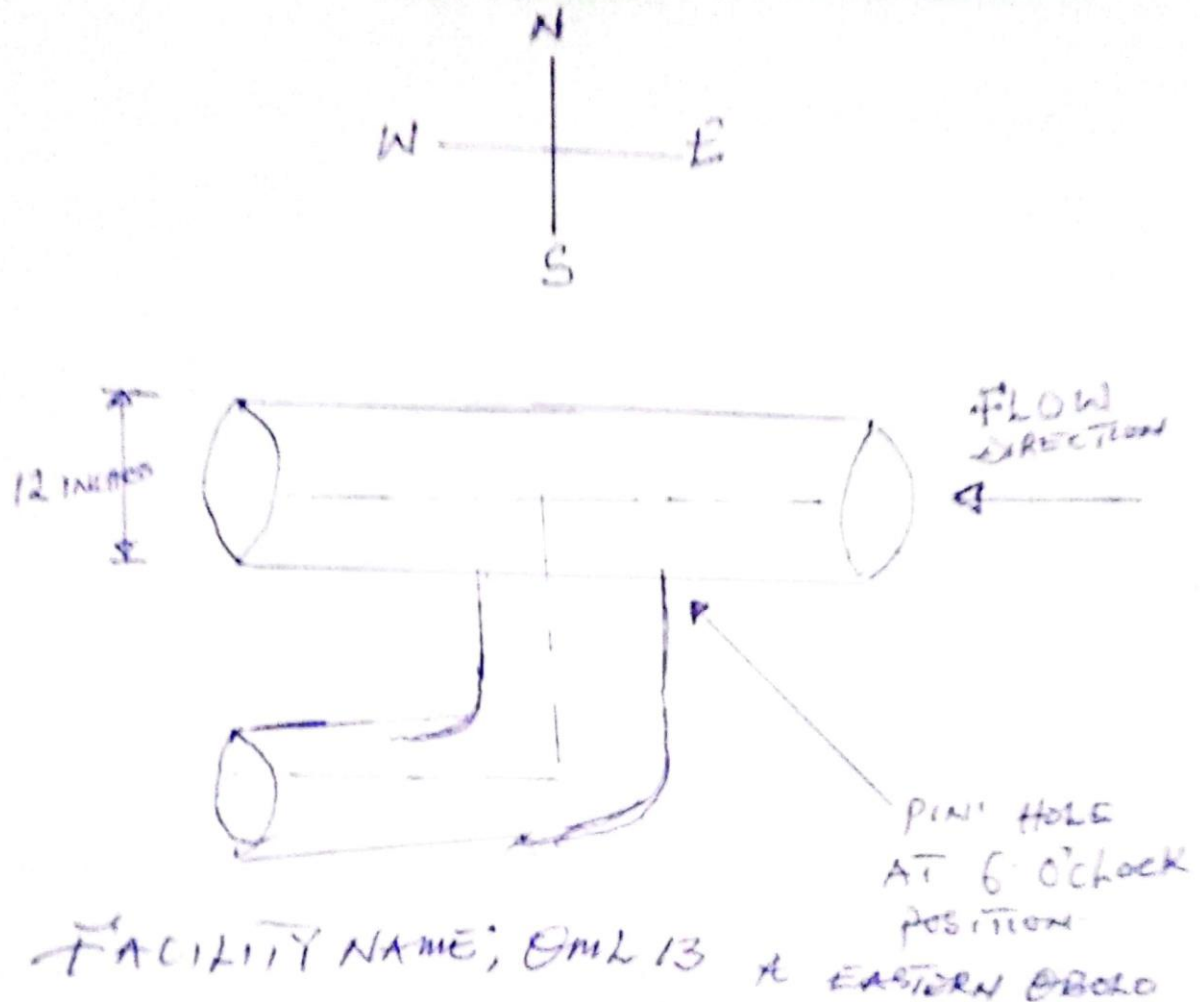
Graphic Description of Leak Point (sketches/illustrations)

| Site Organization | | Mandatory Information Required | |
|---|---|---|---|
| Visual Observation of Hole Point | | <input type="checkbox"/> 12 O' Clock <input type="checkbox"/> 10 O' Clock <input type="checkbox"/> 2 O' Clock <input type="checkbox"/> 3 O' Clock<br><input type="checkbox"/> 4 O' Clock <input type="checkbox"/> 5 O' Clock <input checked="" type="checkbox"/> 6 O' Clock | |
| | | <input type="checkbox"/> Corrosion<br><input checked="" type="checkbox"/> Equipment Failure<br><input type="checkbox"/> Operational/Maintenance Error<br><input type="checkbox"/> Bund wall overflow | <input type="checkbox"/> Vandalization<br><input type="checkbox"/> Oil Theft<br><input type="checkbox"/> Illegal Refining<br><input type="checkbox"/> Others |

| <input type="checkbox"/> Complete rupture | <input type="checkbox"/> Others (specify) <i>Tamper, valve leak</i> |

The oil impacted area should be cleaned immediately  
 by the company.  
 The affected boat should be repaired immediately.  
 The time should be spent in immediately.  
 The community should be compensated based on the impacted area.
