**National Oil Spill Detection and Response Agency**  
**JOINT INVESTIGATION VISIT (JIV) FORM**

| Site Organization | | Mandatory Information Required | |
|---|---|---|---|
| Incident Number | | NNPC E&P/002/04-2025 | |
| Facility Address | | 12" LOCATION 2B LP LINE | |

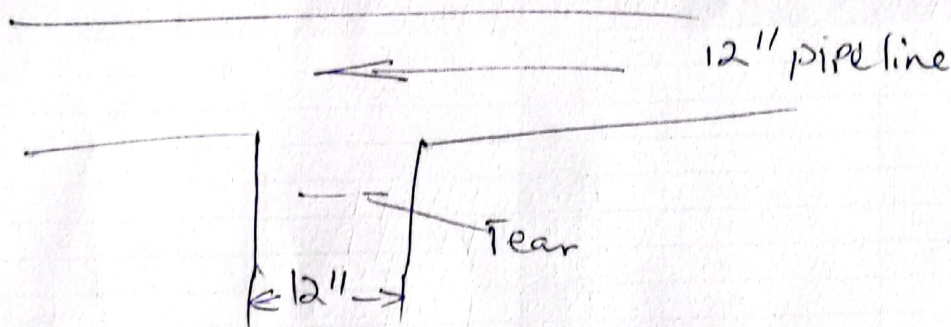
Graphic Description of Leak Point (sketches/illustrations)

A Tear (200mm) in the T-jointed pipe on the 12" pipeline

Carry out sectional replacement of the affected pipeline  
and commence immediate remediation of the  
re-impacted sites.
