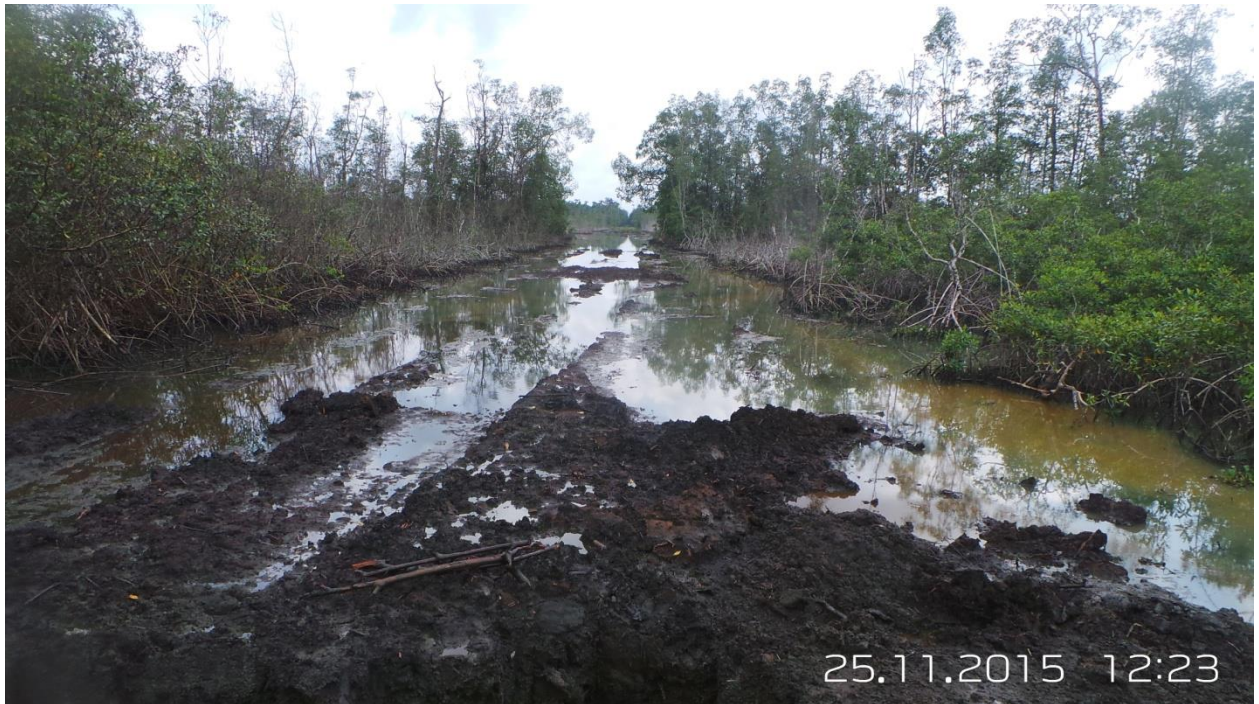
**Fig A: Spill point just before excavation**
