**PICTURES ON SITE:**

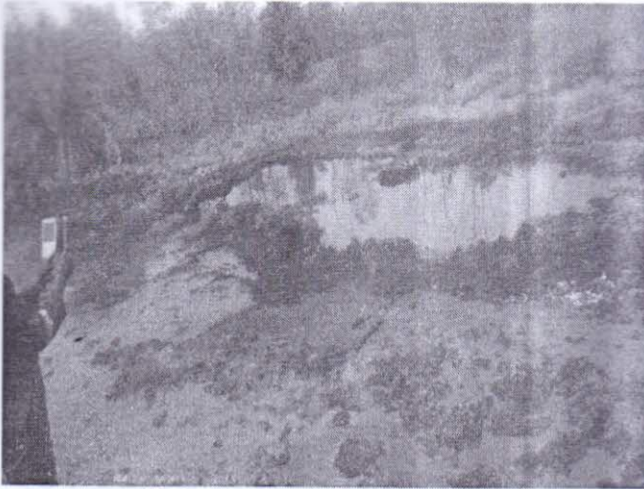
**Figure 1: BEFORE EXCAVATION**

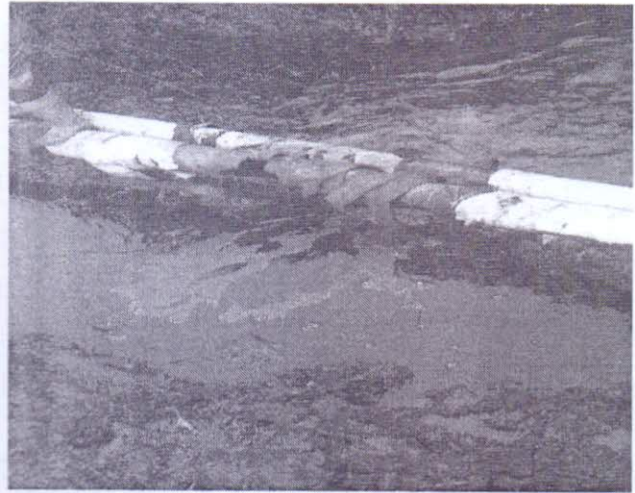
**Figure 2: BLAST POINT FOUND AFTER EXCAVATION**
