National Oil Spill Detection and Response Agency  
**JOINT INVESTIGATION VISIT (JIV) FORM**

| Site Organization | | Mandatory Information Required | |
|---|---|---|---|
| Company Name | | TULCAN ENERGY | |
| Incident Number | | TUL/TSB/INC001/2026 | |
| Location OML: | PPL-244 Tem-Sofot Bank PIPELINE ROW | GPS Coordinate | N 504233<br>E 410732 |

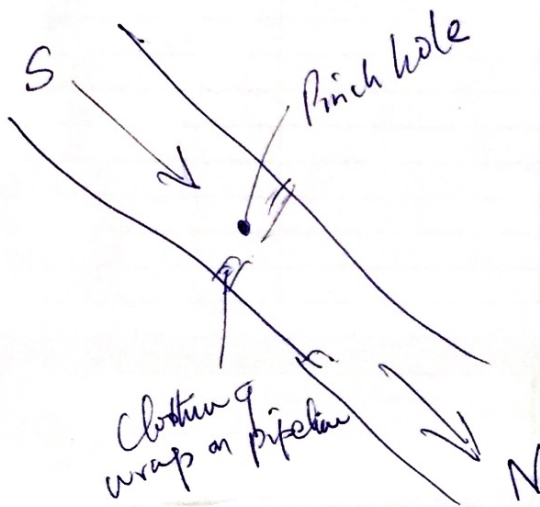
Graphic Description of Leak Point (sketches/illustrations)

- ☒ Drilled Holes
- ☐ Blast
- ☐ Flare System/Bund wall failure
- ☐ Saver pit overflow
- ☐ Third party tampering with valve setting
- ☐ Third party tampering with flange
- ☐ Inward dent
- ☐ Surge vessel overflow
- ☐ Relief valve failure
- ☐ Others (specify).....

An unknown person tampered with the Pipeline.  
At the time of excavation a clothes was observed wrapped around the pipeline.

Commence recovery immediately and  
 carry out clean-up of all impacted area.  
 Ensure surveillance of the pipeline ROW.
