**EVIDENCE OF PHOTOGRAPH TAKEN AT SITE**

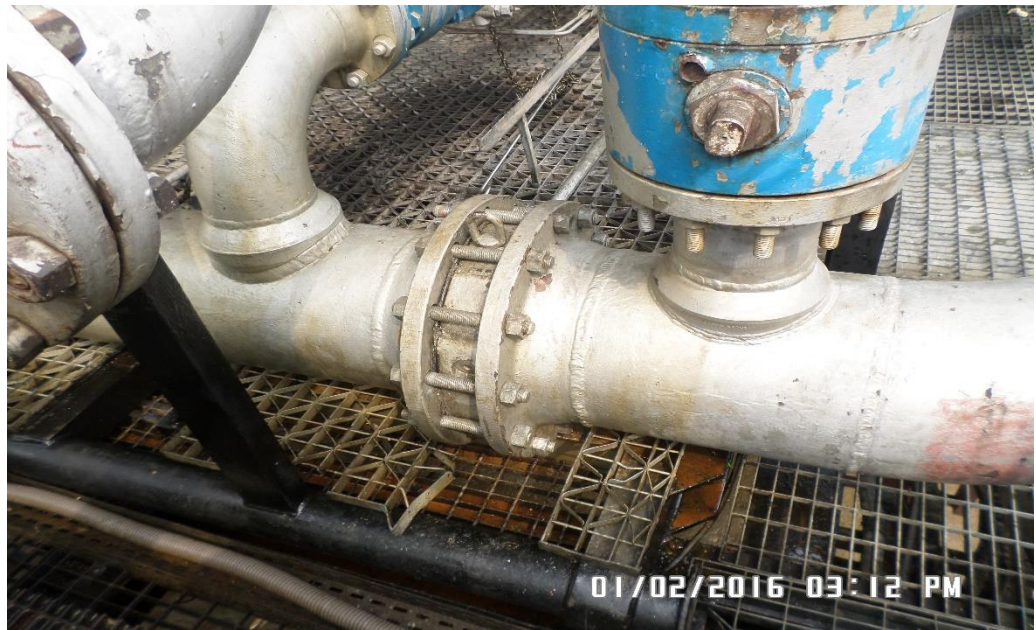
**Figure 2.1.** Spill point

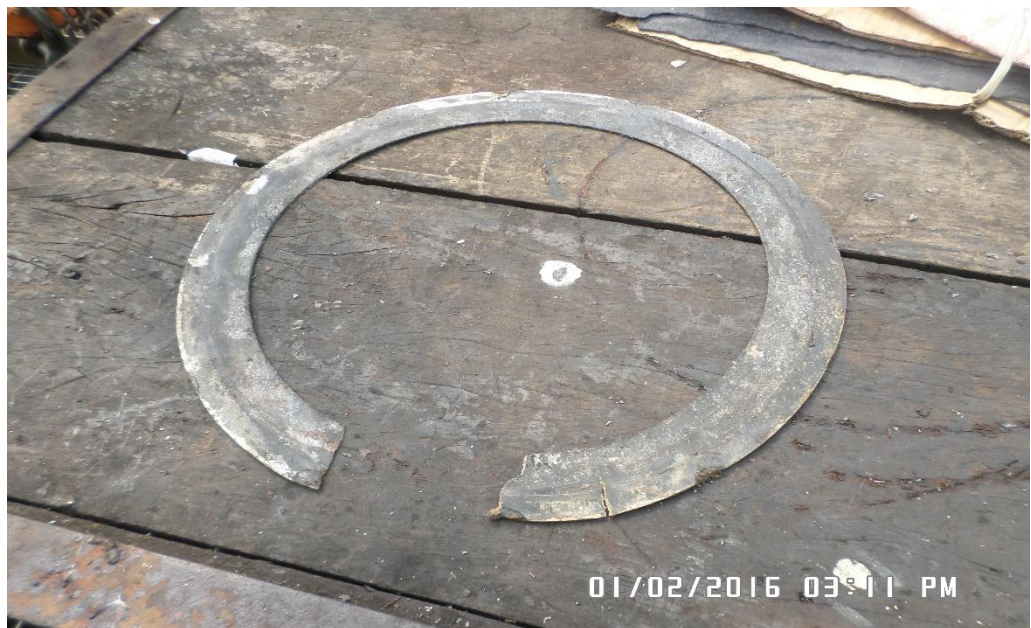
**Figure 2.2.** Failed orifice (Seal)
