### 3. EVIDENCE OF PHOTOGRAPH TAKEN AT SITE

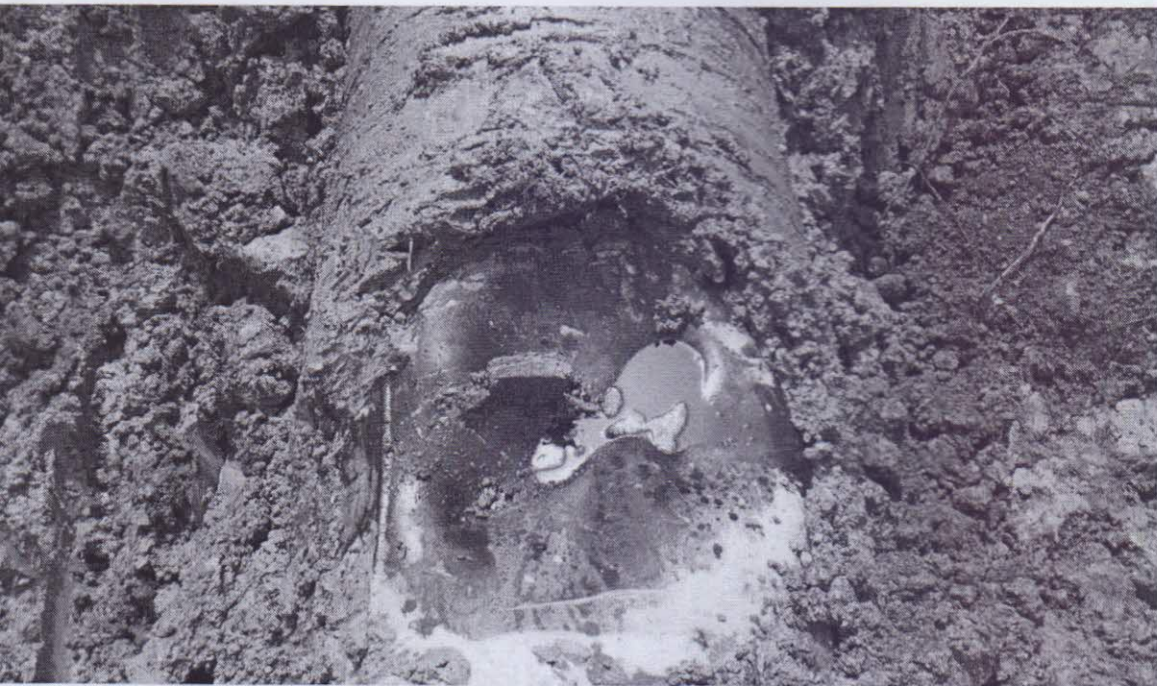
**Figure 2.1.**

Incident (Blast) Point

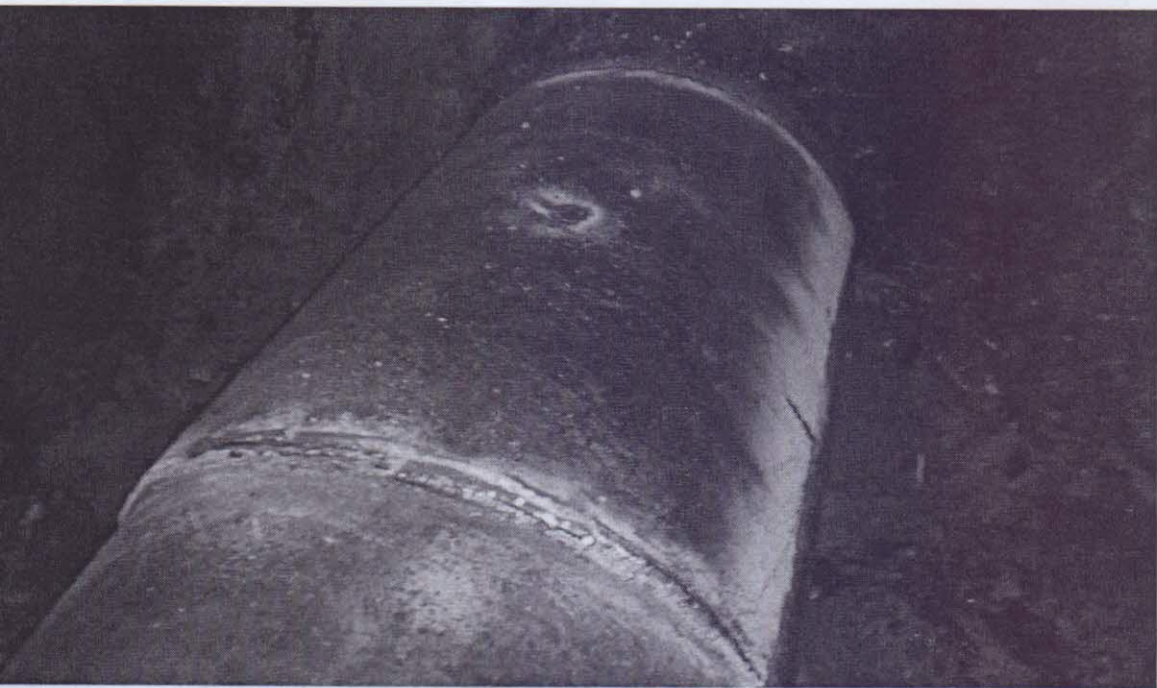
**Figure 2.2.**

Complete welded section

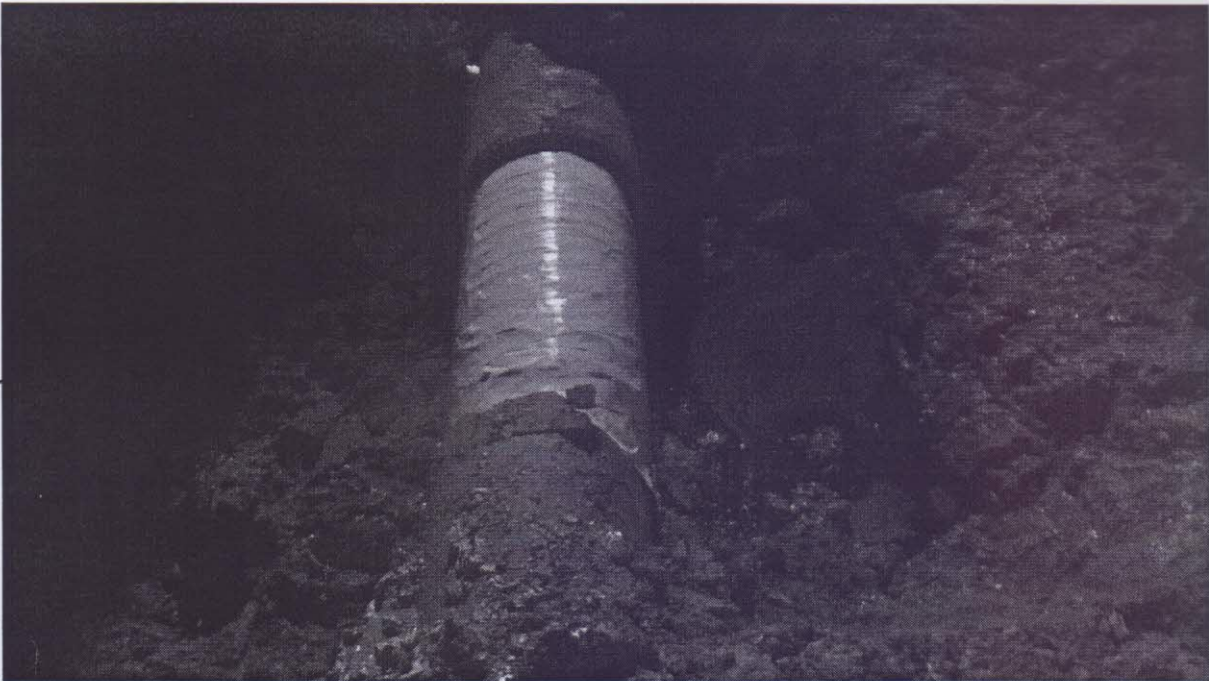
**Figure 2.3.** Rapped point

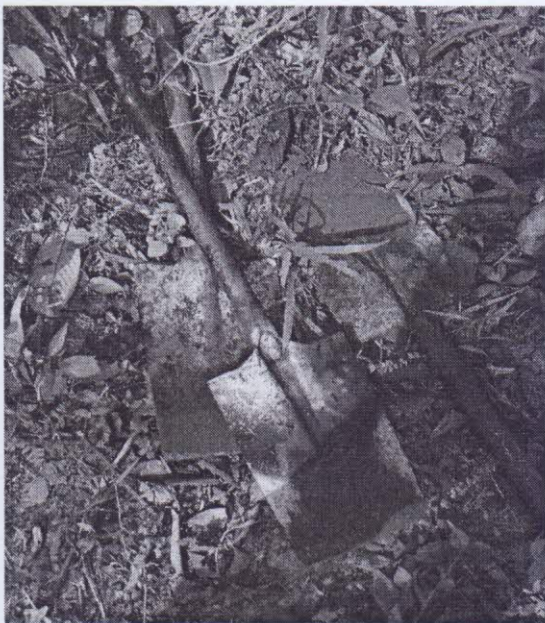
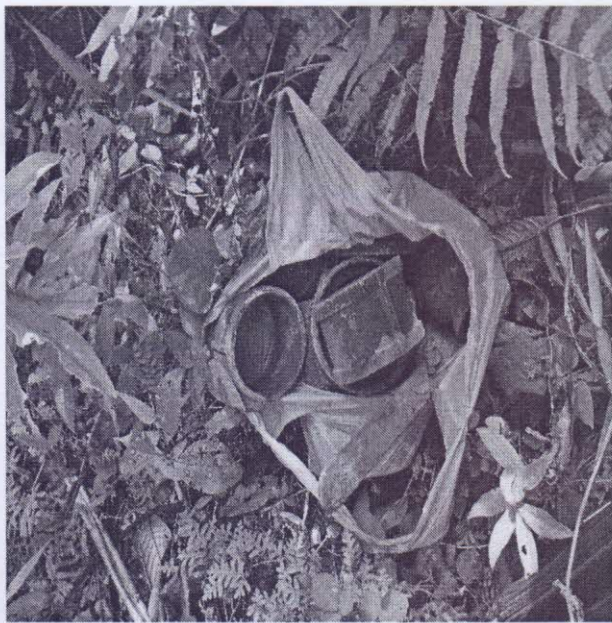
**Figure 2.4** Recovered Items from site.

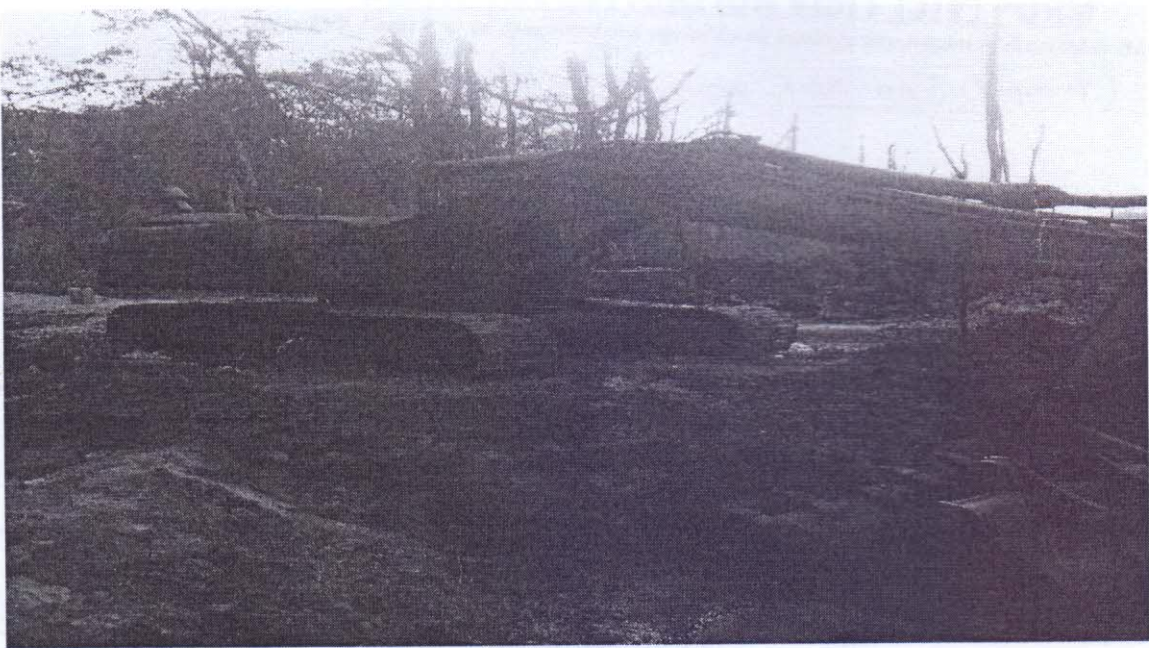
**Figure 2.5**

Burnt Excavator.
