# PHOTOGRAPHS ON SITE

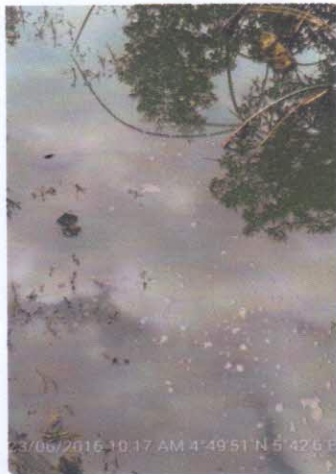
INCIDENT POINT

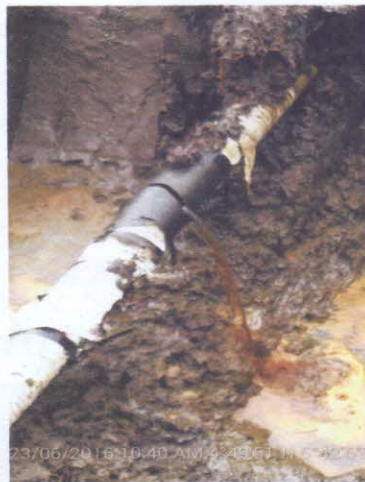
AFTER EXCAVATION

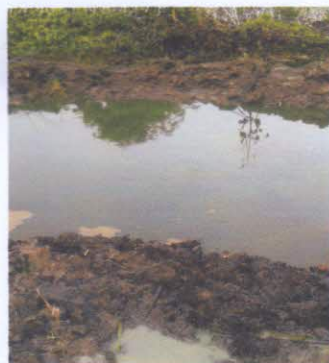
OIL SPILLED WITH ROW AND VEGETATION

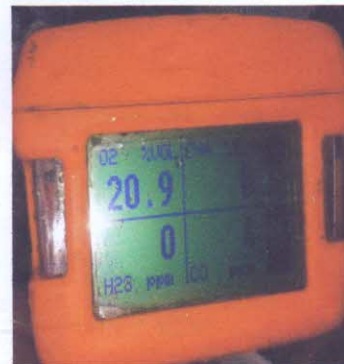
VOLUME OF GAS TESTED DURING THE JIV
