JIV was not necessary and repairs was carried out  
**PHOTOGRAPHS ON SITE**

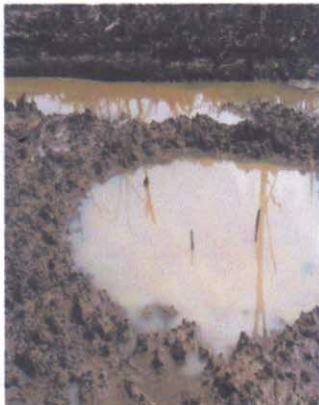
**INCIDENT POINT**

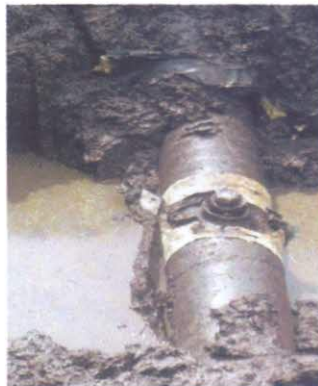
**AFTER EXCAVATION**

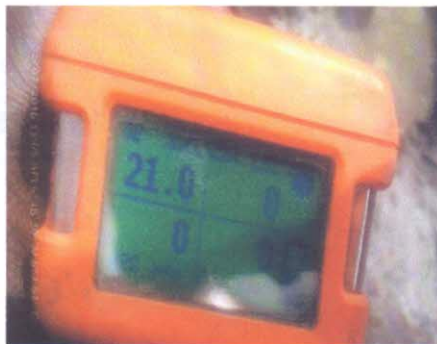
**VOLUME OF GAS TESTED DURING THE JIV**
