# PHOTOGRAPHS ON SITE

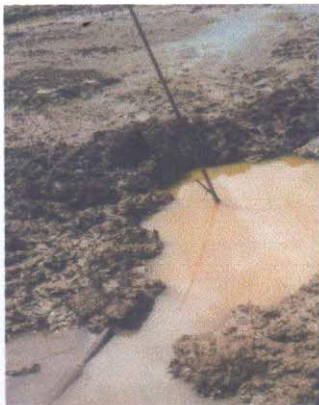
INCIDENT POINT

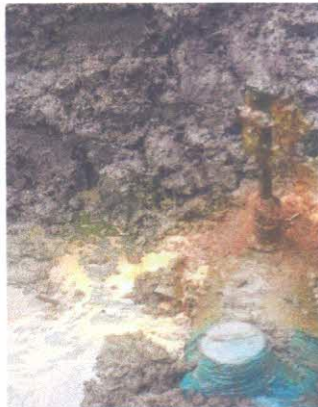
AFTER EXCAVATION

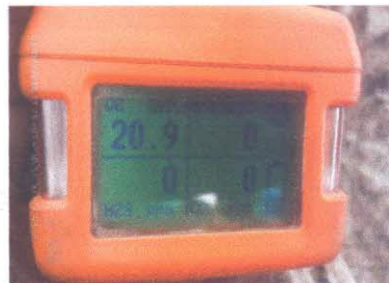
VOLUME OF GAS TESTED DURING THE JIV
