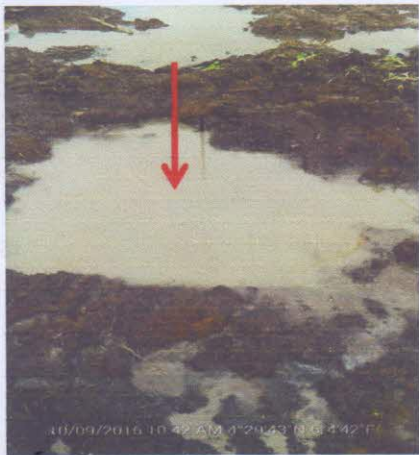
Incident Point

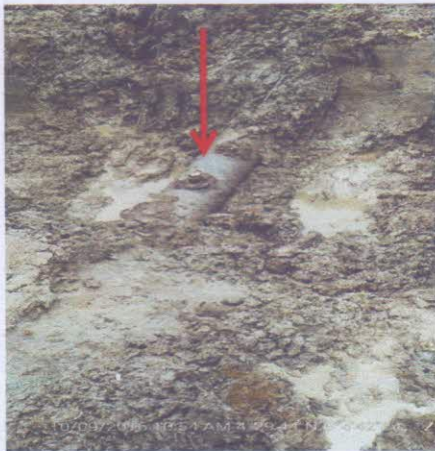
After Excavation
