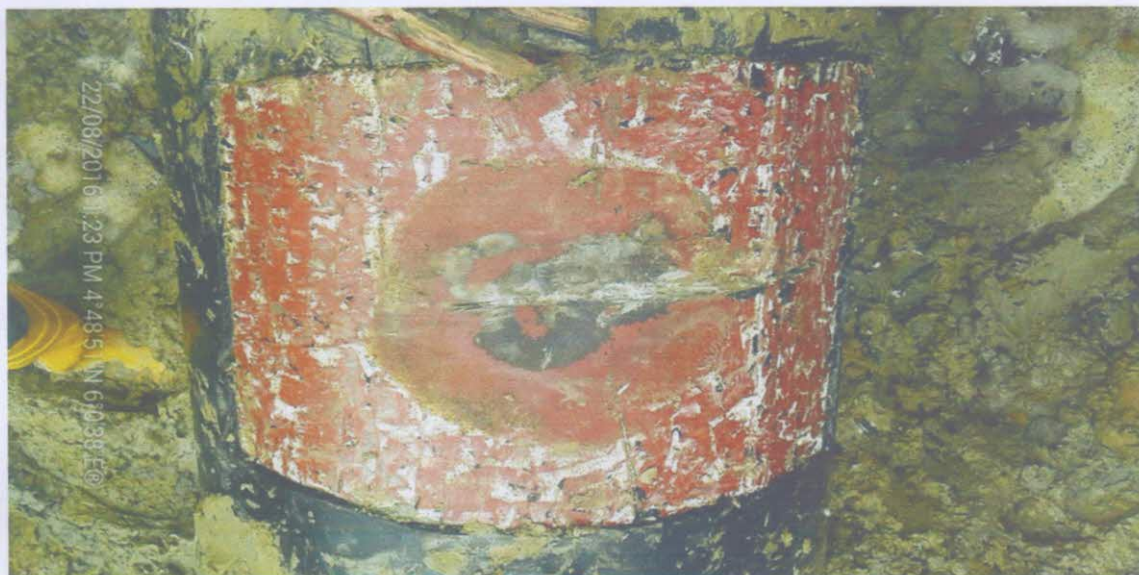
**Figure 2.1.** 250mm long hacksaw cut with dent
