### 3. PICTURES TAKEN AT SITE

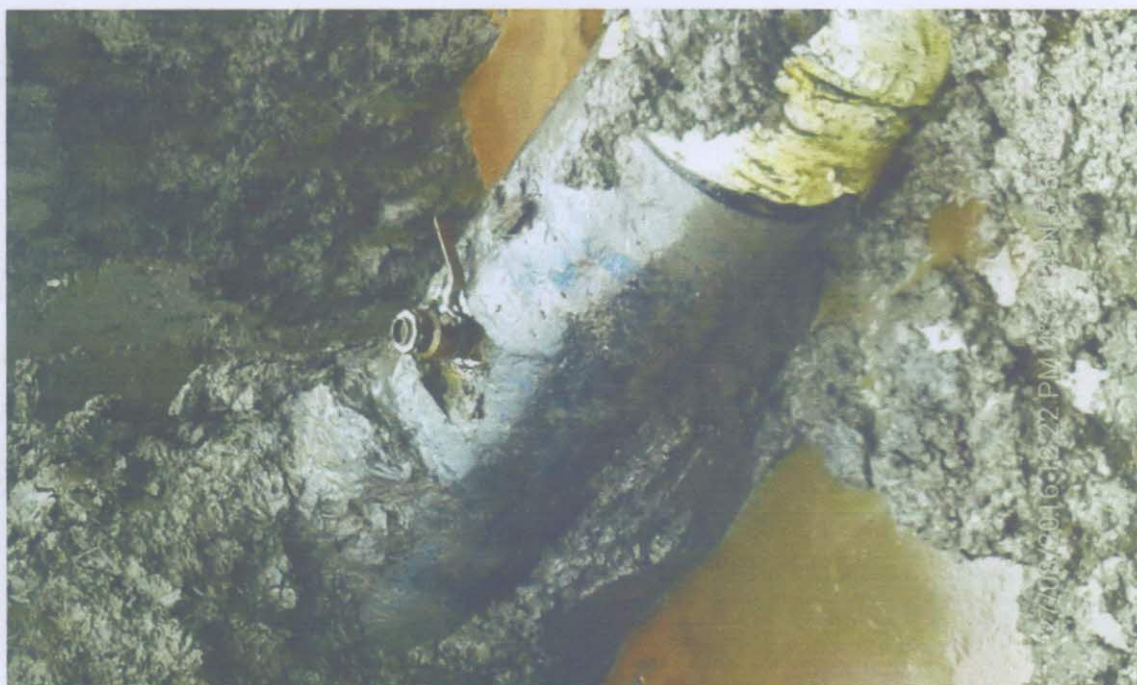
**Figure 2.1**

**Bunkering Point**

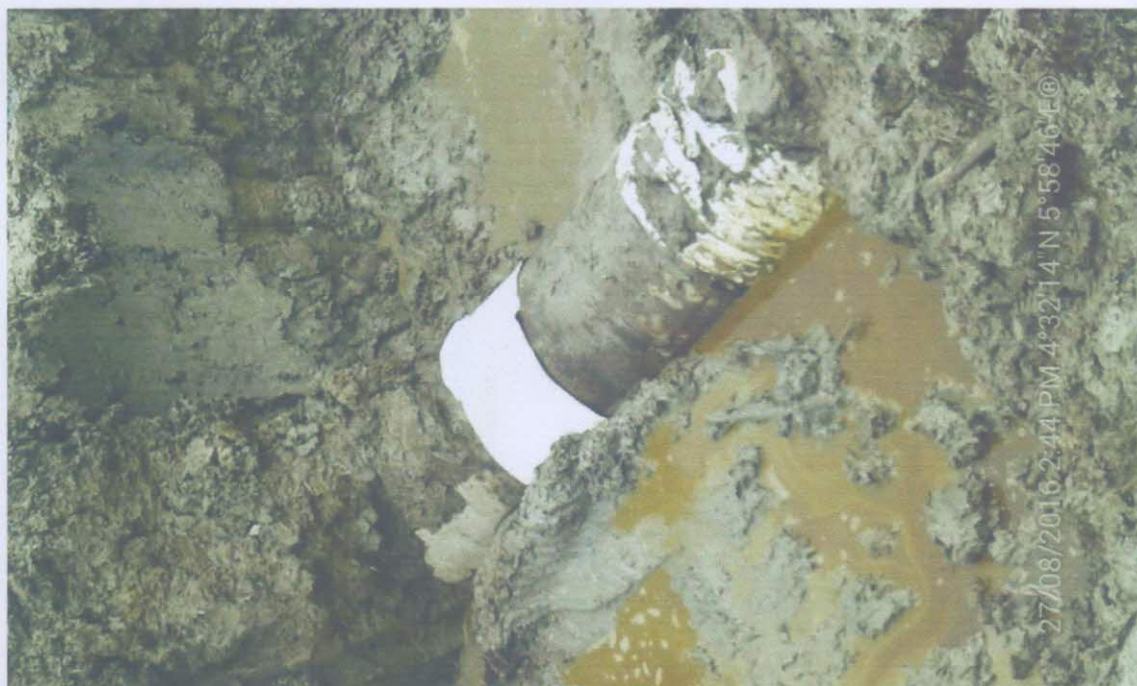
**Figure 2.2.**

**Leak Point patch welded**
