# PHOTOGRAPHS ON SITE

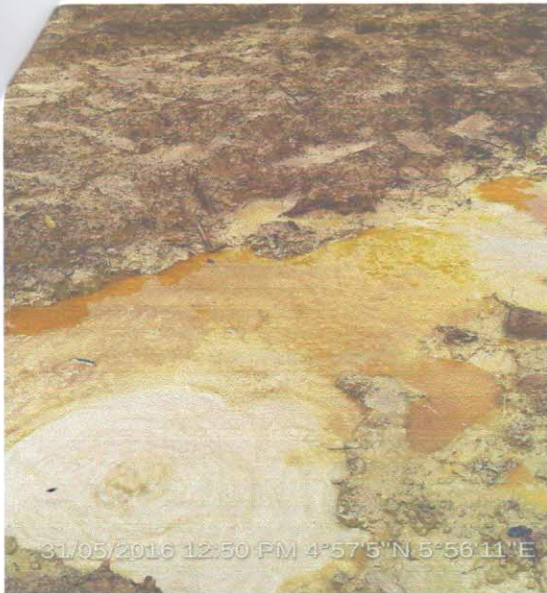
**Incident Point**

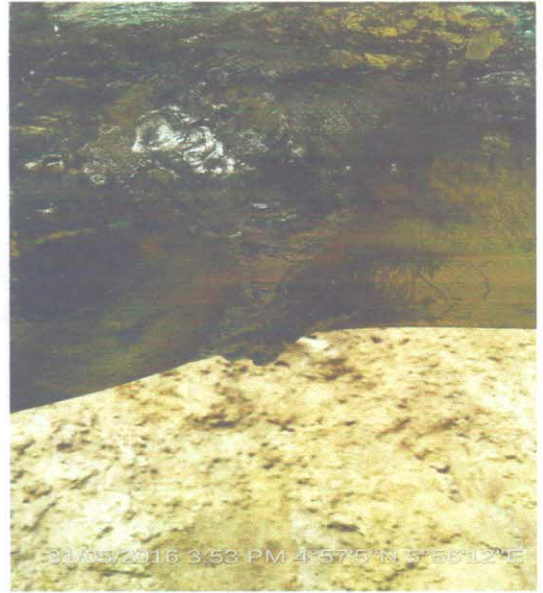
**After Excavation**
