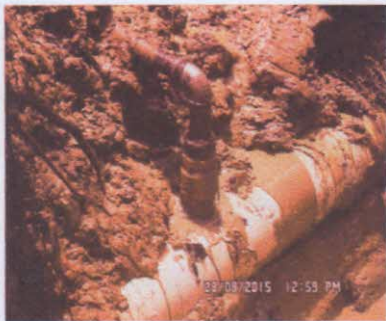
After excavation.
