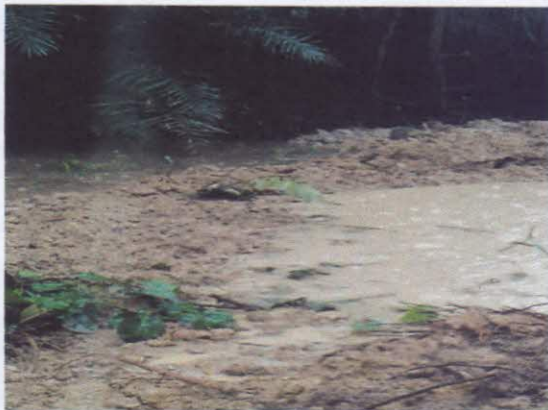
Point after barricading to expose pipe.

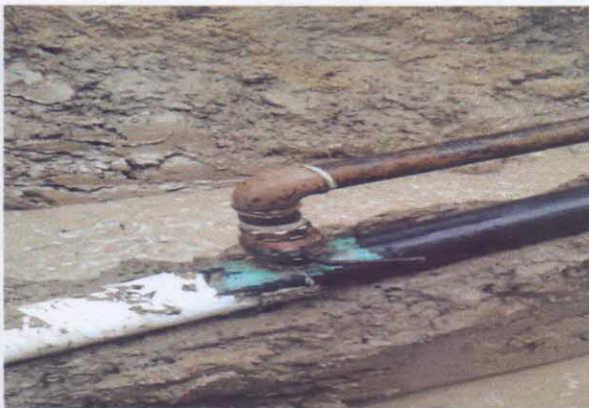
Exposed pipe showing course of spill.
