## PHOTOGRAPHS TAKEN ON SITE

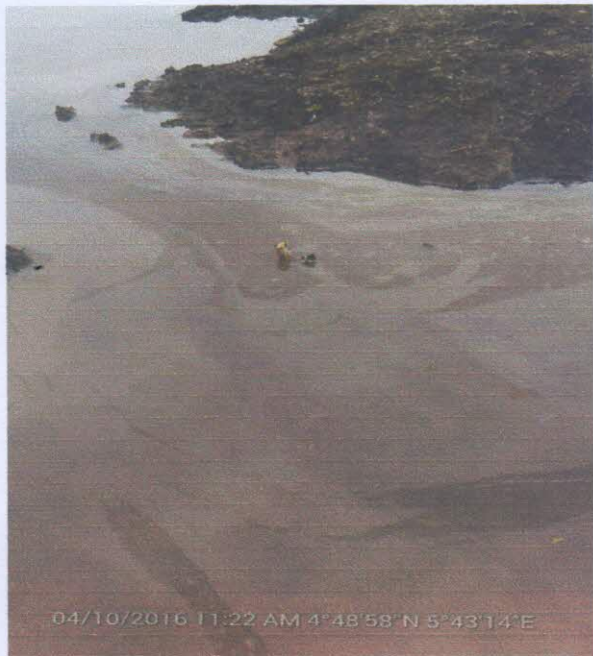
**Fig 1: Impacted area**

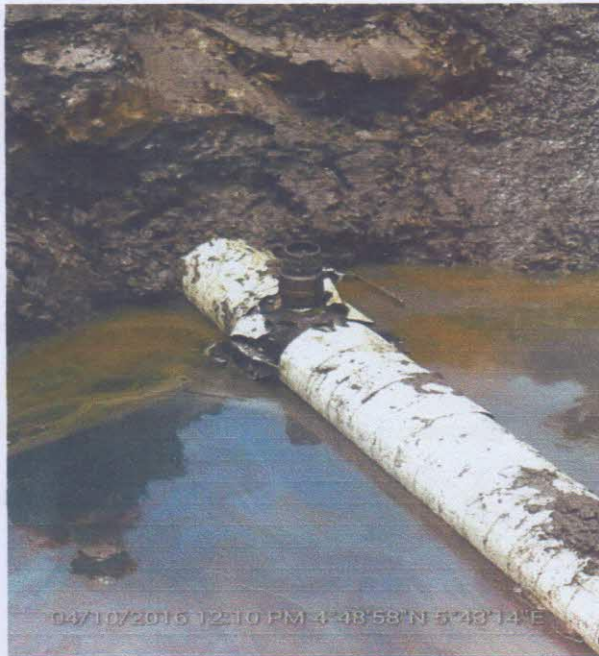
**Fig 2: Spill point**

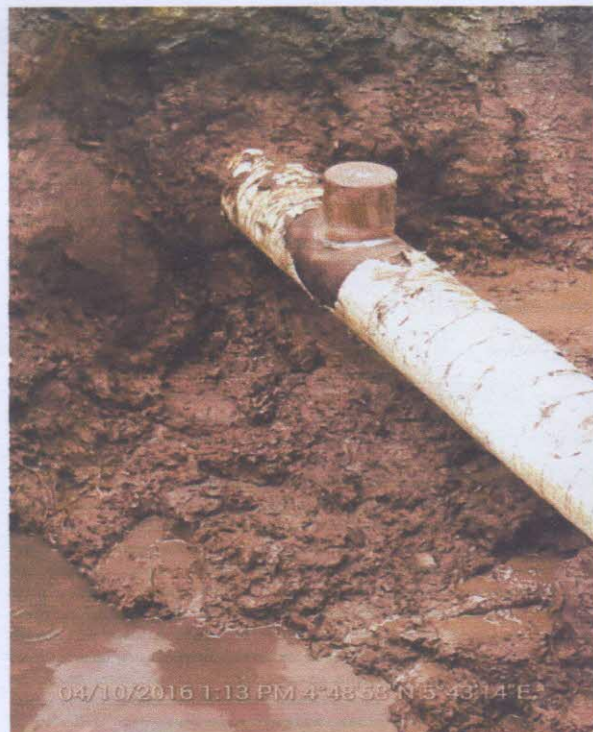
**Fig 3: Leak point after repairs**

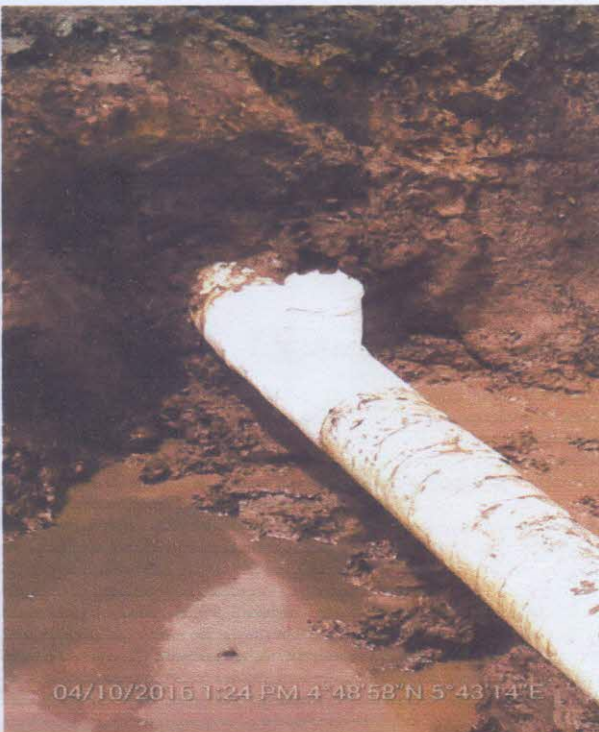
**Fig 4: Repaired point wrapped**
