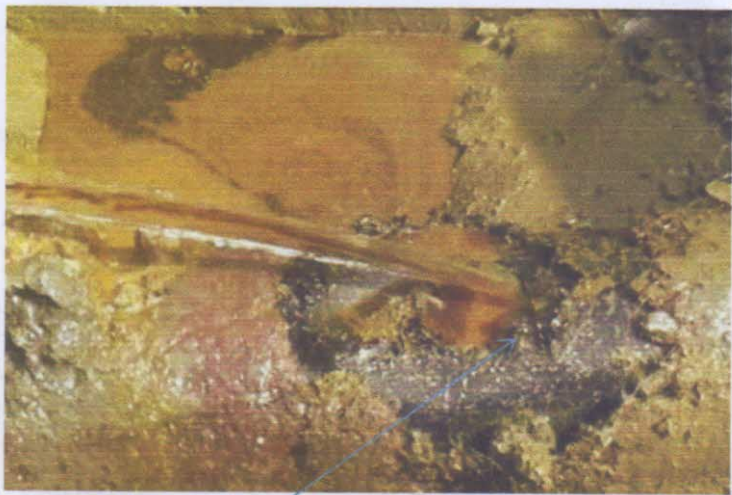
200mm Hacksaw cut on the facility at Point A (Before repair)

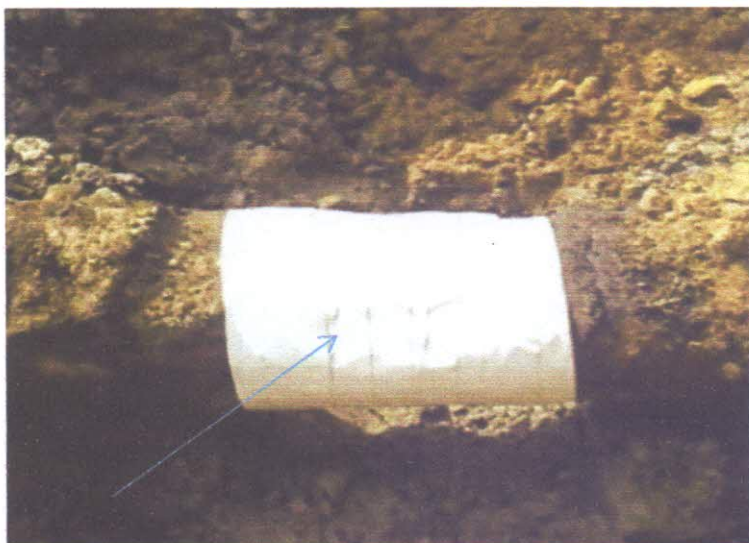
Hacksaw cut on the Facility at Point A (After repair)

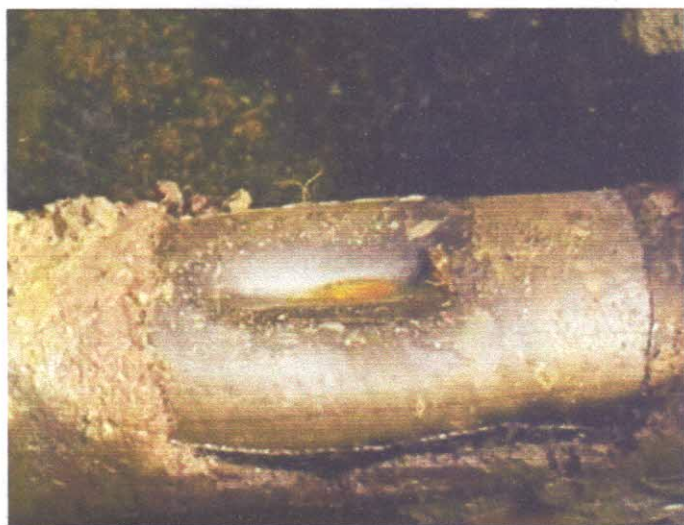
A Section of the Facility, Point B on which Explosive device was used by the Suspect (Before repair)

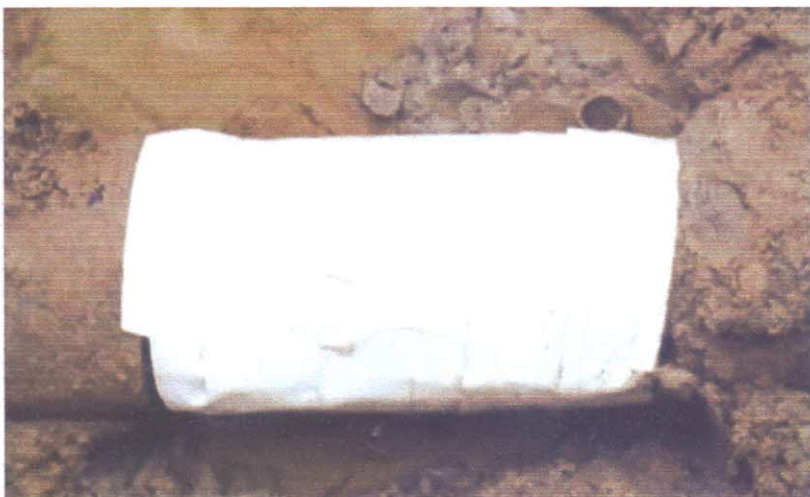
Picture of the Point B on the Facility (After repair)

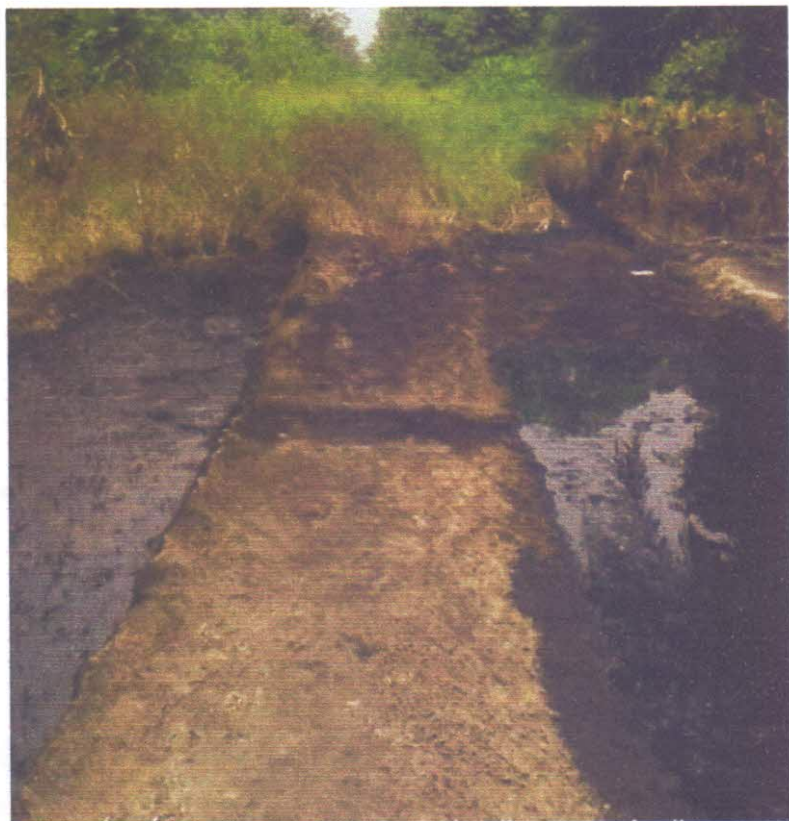
Picture of the Impacted Area (Within the Company's right of way)
