**PHOTOGRAPHS TAKEN ON SITE: 10' CLOUGH CREEK/TEBIDABA PIPELINE AT AZAGBENE**

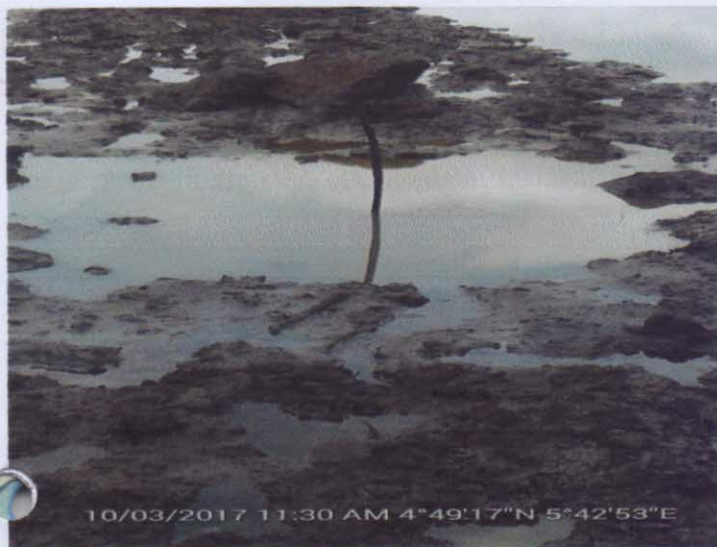
**A: SITE PONT ARRIVAL**

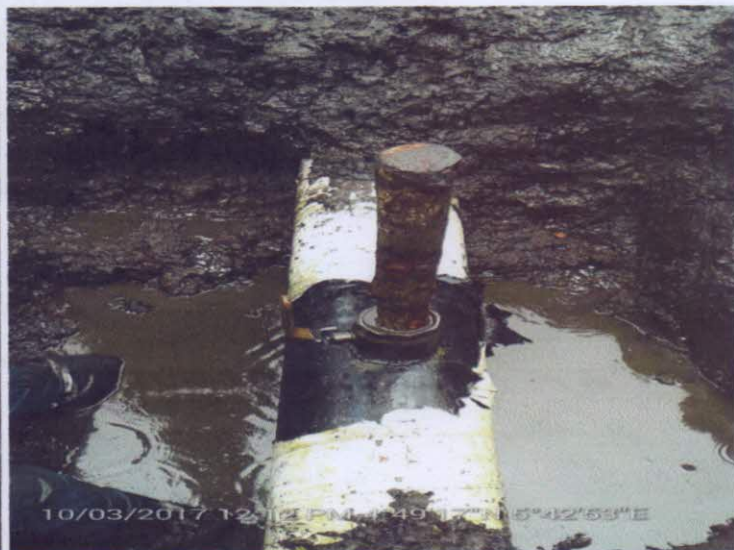
**B: LEAK POINT AFTER OPENING AND PEGGING**
