PICTURE TAKEN AT SITE

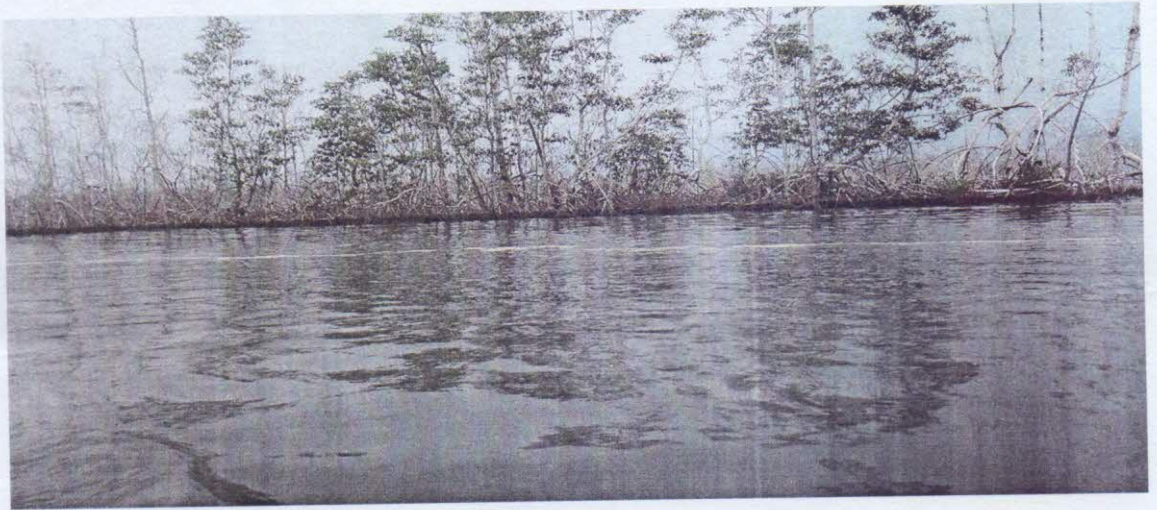
Figure 2.1. The Incident Point

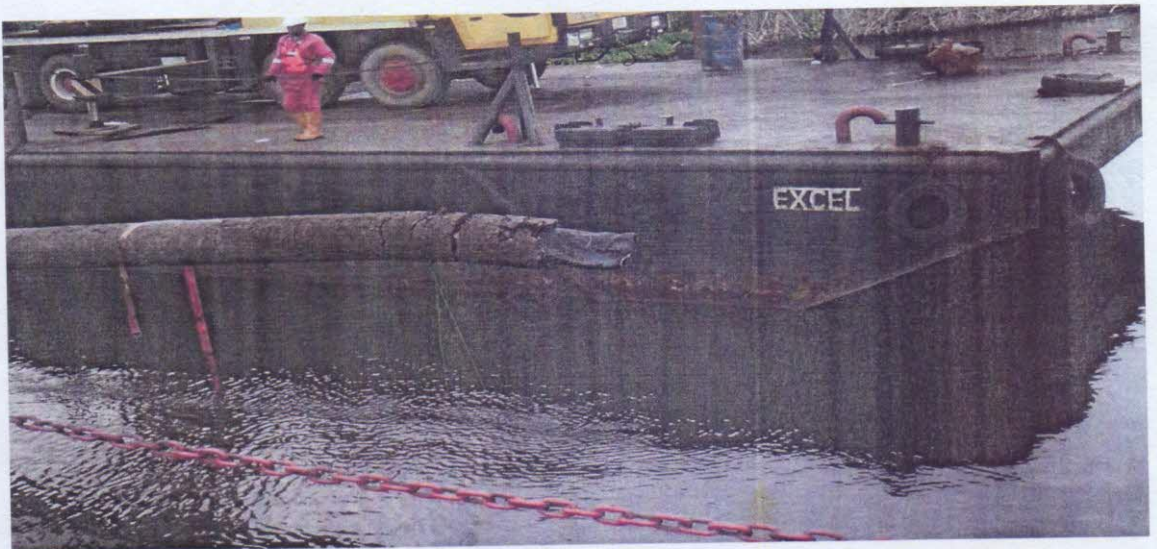
Figure 2.2. Oil sheen on water
