## SOME PHOTOGRAPHS TAKEN DURING THE JOINT INVESTIGATION VISIT (JIV)

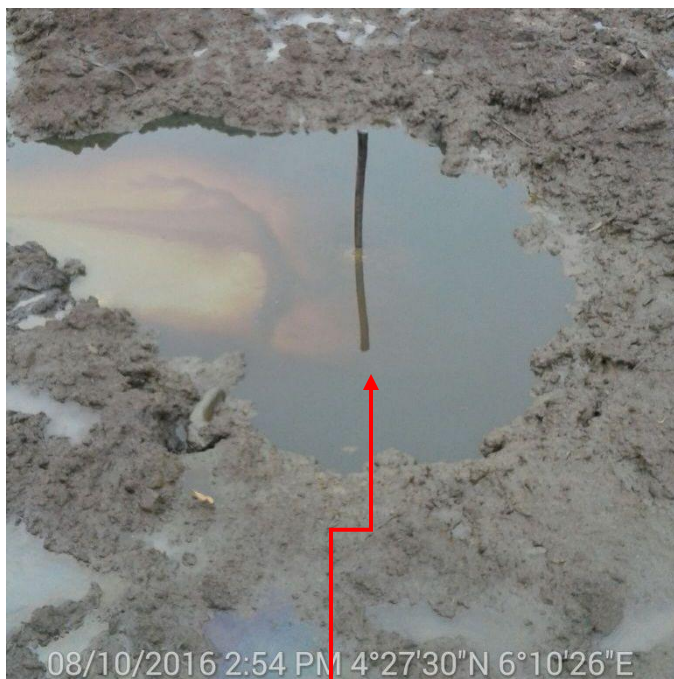
**Fig A: The Incident Area just before excavation**

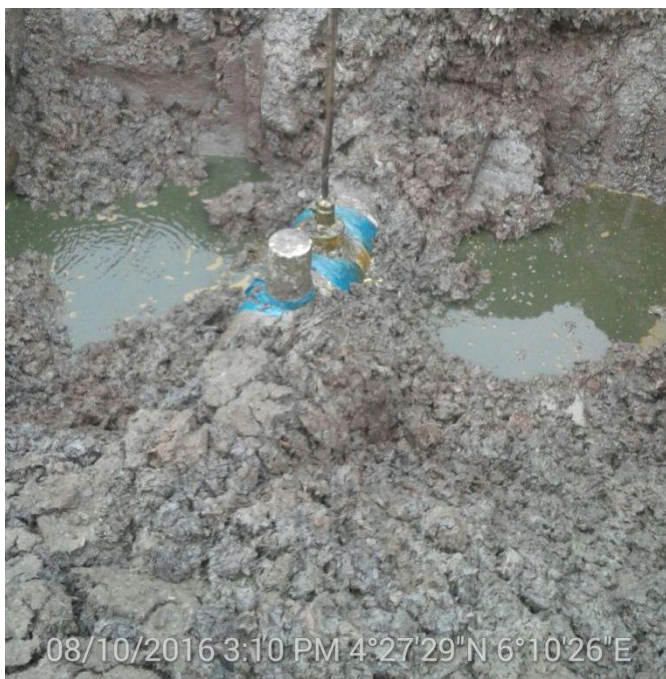
**Fig B: Incident facility after excavation/Spilled Crude Oil**
