**SOME PHOTOGRAPHS TAKEN DURING THE JOINT INVESTIGATION VISIT (JIV)**

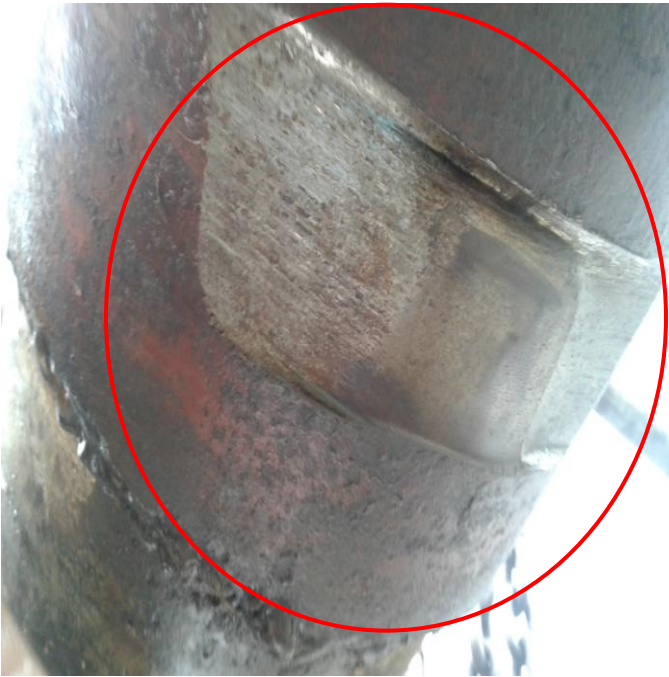
**Fig A: The Incident Facility/Leak Point**

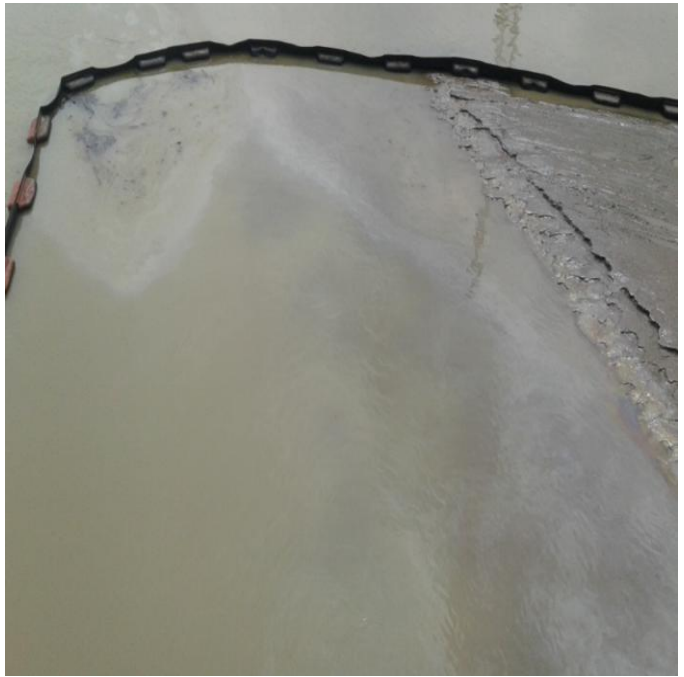
**Fig B: Oil sheen within the Platform Area**
