## NATIONAL OIL SPILL DETECTION AND RESPONSE AGENCY JOINT INVESTIGATION VISIT (JIV) FORM

4. Site Details  
i. Site/Location: 48" Export line to C.L.P. (Crude Loading Platform)  
ii. State: Delta iii. L.G.A: Brimbu  
iv. Spill Co-ordinates: N(m) 138974.4  
E(m) 317010.6

## THE 48 INCH FOT EXPORT PIPELINE LEAK INCIDENT OF 4<sup>TH</sup> MARCH 2014

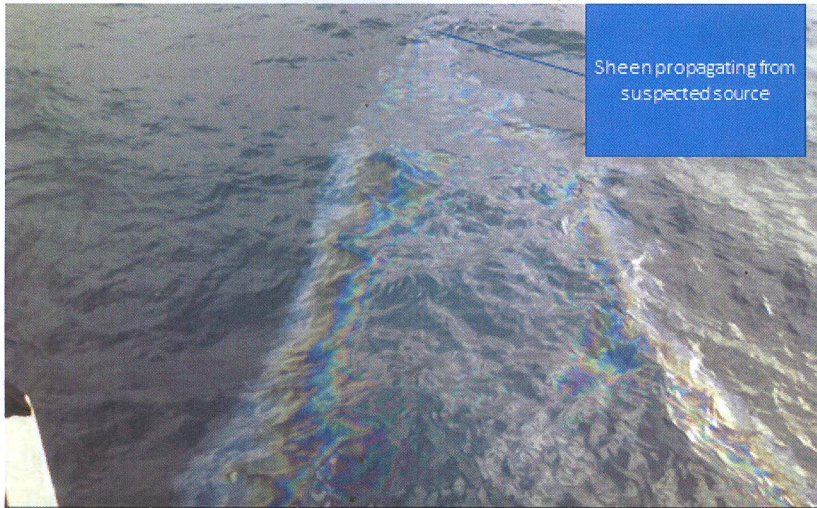
Sheen propagating from suspected source

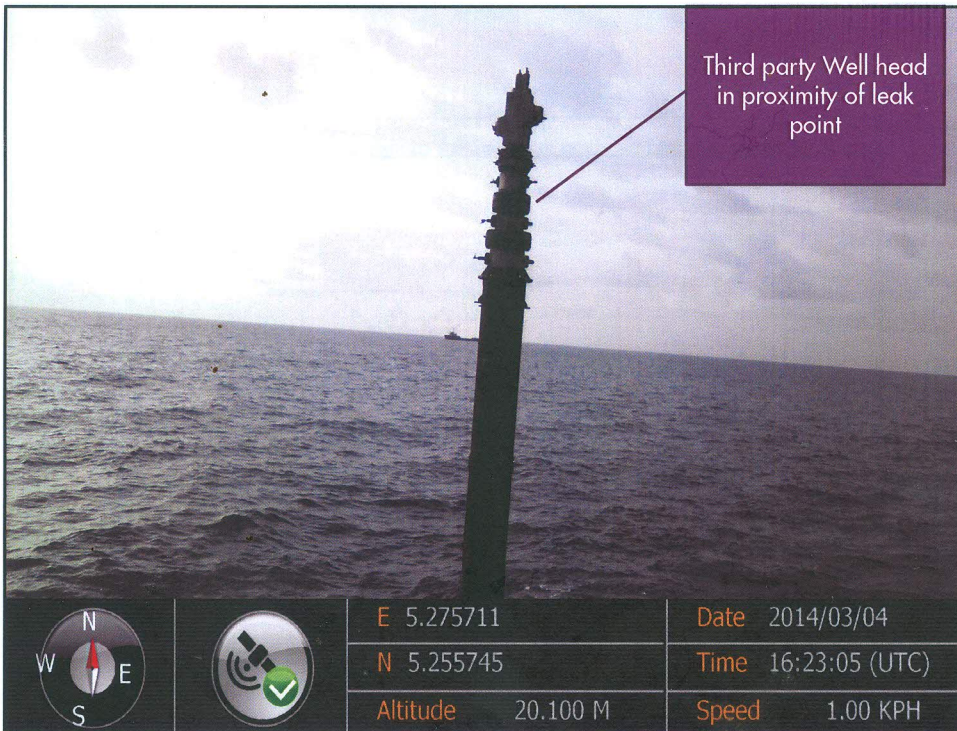
Third party Well head in proximity of leak point

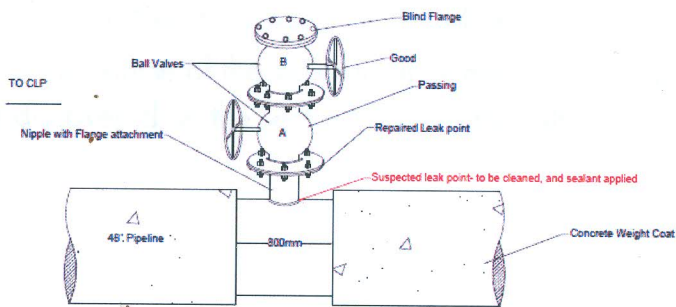
Schematic Diagram of Valve Assembly found Installed on Export Line

- v. Visible Sign of Third Party Interference  
☐ Hacksaw Marks ☐ Drilled Holes ☐ Blasting ☐ Theft ☐ Acid  
☒ Others (specify) A retrofitted valve assembly installed on the export line (48")

- DSV was deployed to the leak site on 6/03/2014 to carry out leak detection and repairs operations by on-board divers.
- Diving for the leak detection commenced but unsuccessful.
- On 7/3/2014, Diving continued and leak point discovered on the pipeline. A retrofitted valve assembly installed on the export line was discovered to be the source of leak. (See pictures and images in next slides)
- The assembly was not part of the export pipeline construction.
- The end flange of the retrofitted assembly had 5 of the 8 stud bolts removed, i.e. only 3 in place. The 3 were slack and loosened with free hand by the divers
- The end flange and bolts were unusually too new for a pipeline of 42yrs under seabed, suggesting it was a recent activity- ref the picture of the flange

VALVE ARRANGEMENT ON 48" EXPORT PIPELINE AT FORCADOS (Status as at 13:00hrs- 11-03-14)

- Divers stopped the leak by sealing the leak point using a special epoxy resin
- The repaired leak point was leak-tested okay.
- During the course of the leak repair, some foreign objects were discovered on the seabed around the retrofitted valve assembly.

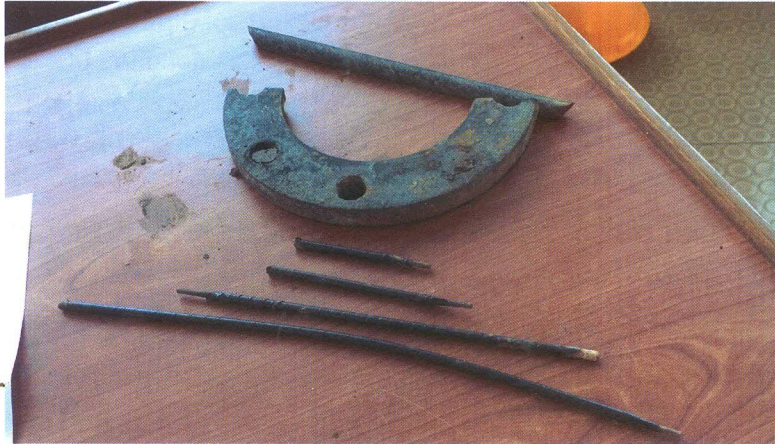
## Welding Electrodes and Metals Found Underwater

- ① Schematic diagram of the RETROFITED VALVES, since pictures could not be taken because of the muddy nature of the sea bed.
- ② Electrodes, flange, and sealant were also brought out by the diver as evidences of third party interference
- ③ The Export line 48" could not be lifted because of the size
