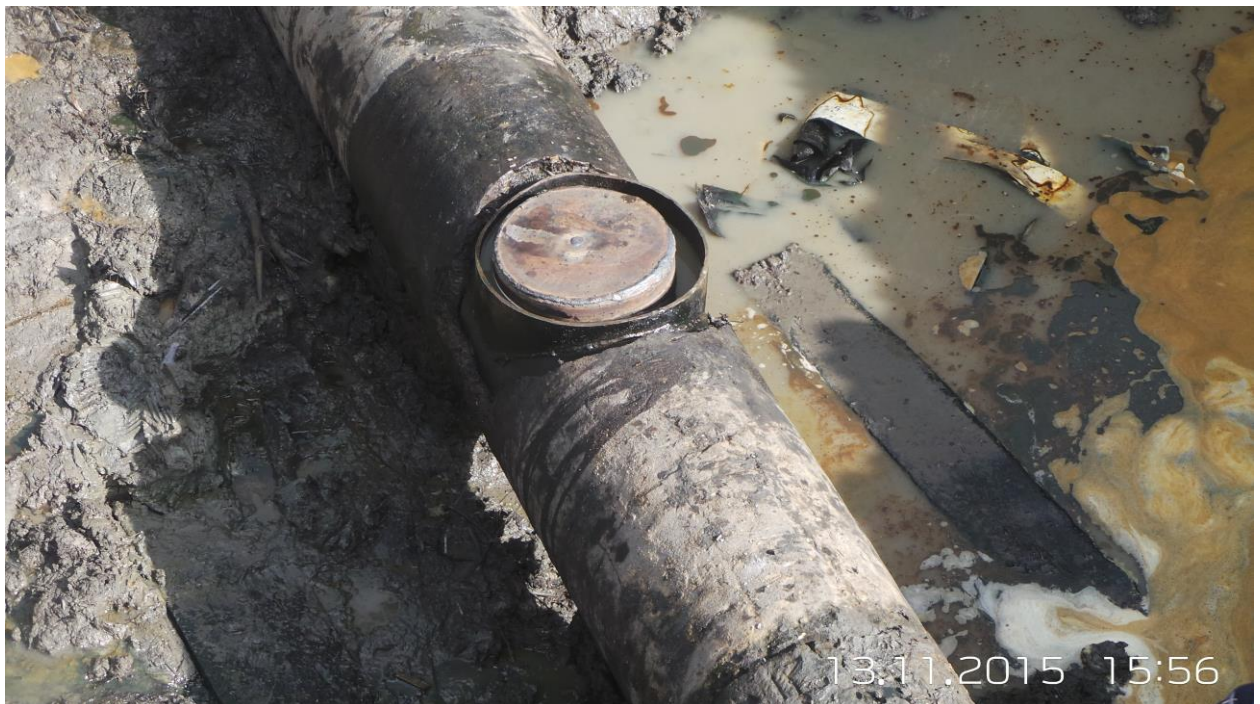
**Fig B: Valve was cut and coned**

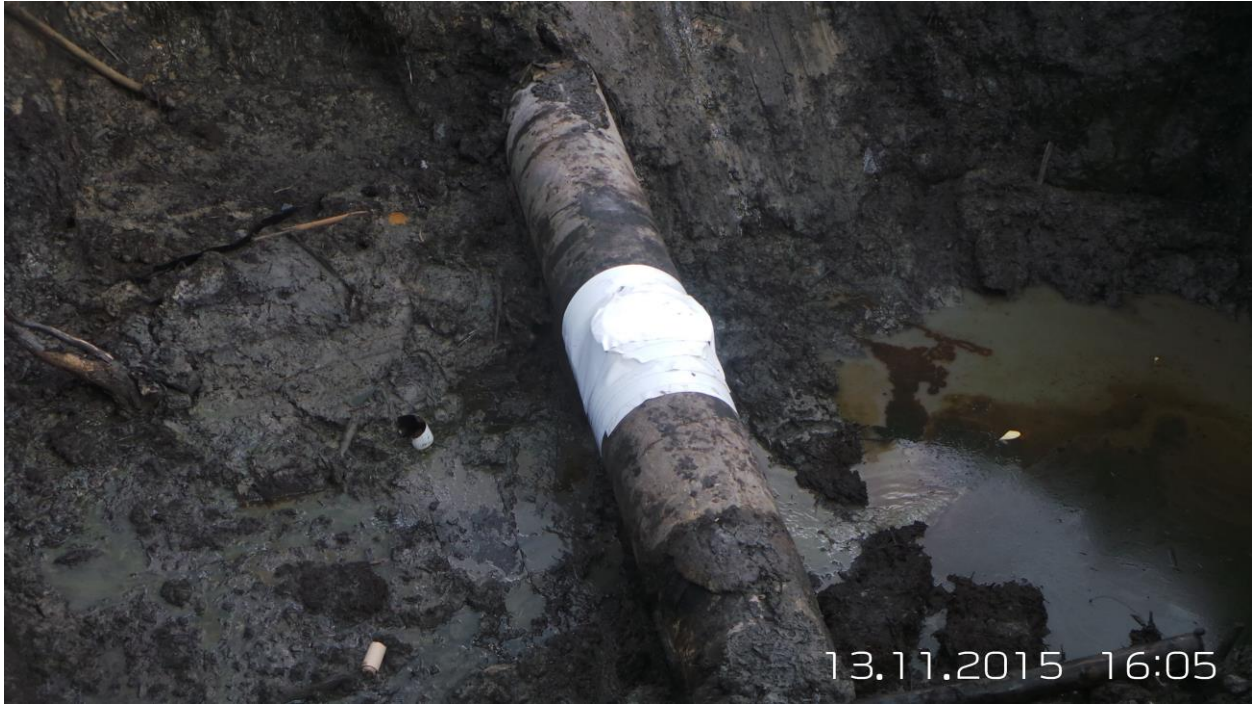
**Fig C: Wrapping/Tape coating of incident facility**
