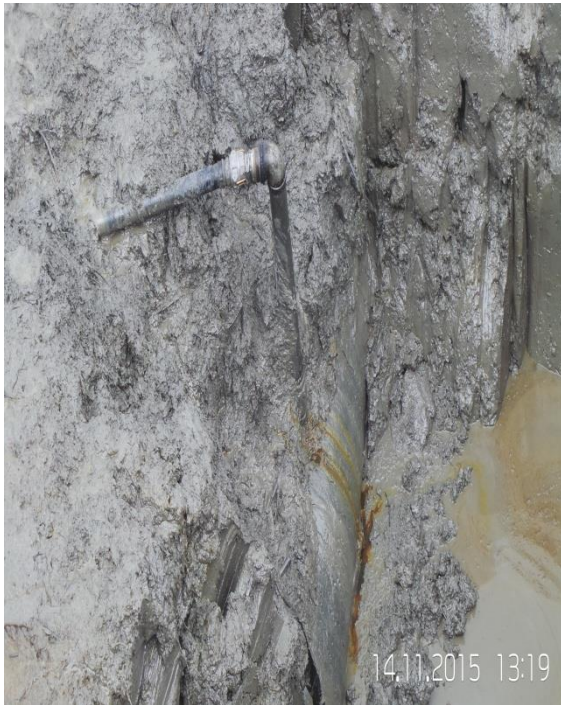
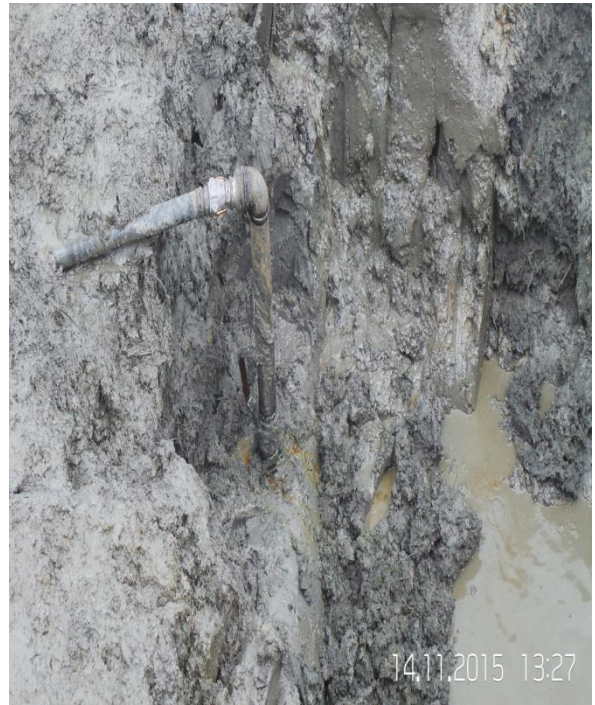
**Fig A: Spill point during excavation**
