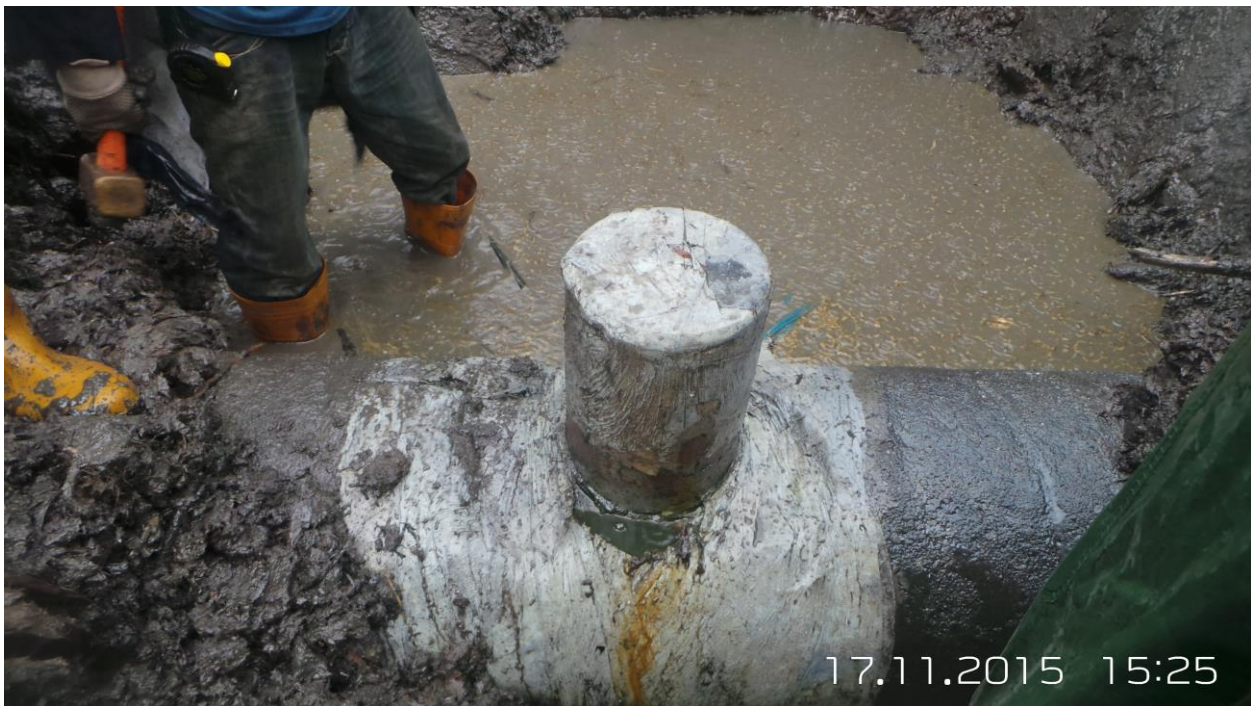
**Spill point**
