## PHOTOGRAPHS TAKEN DURING JIV

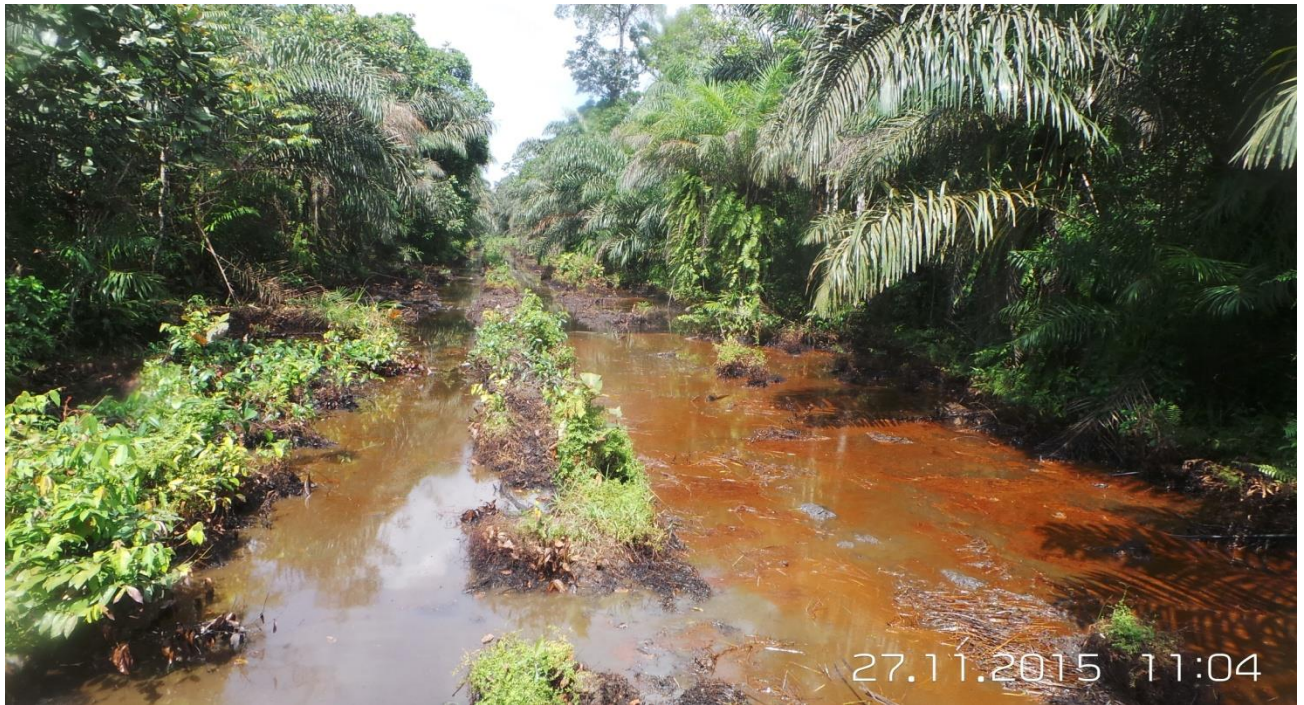
**Fig A: Spill point just before excavation**

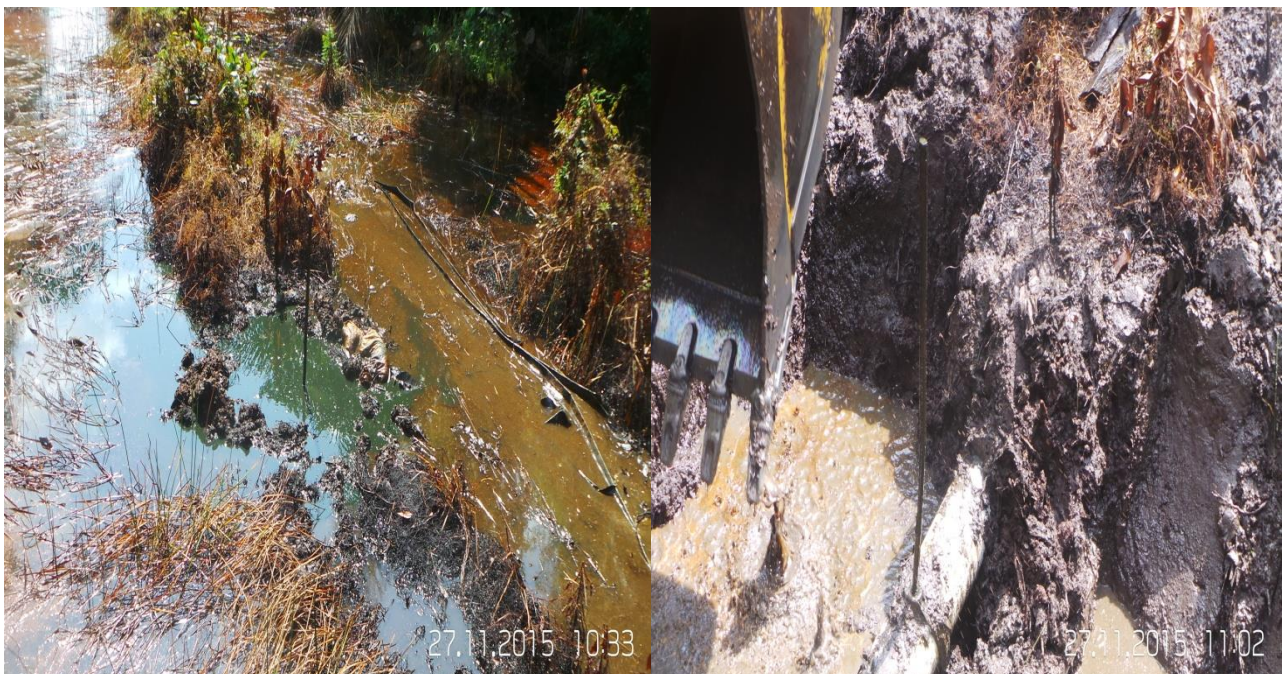
**Fig B: Spill point during excavation**
