**PICTURES TAKEN AT SITE:**

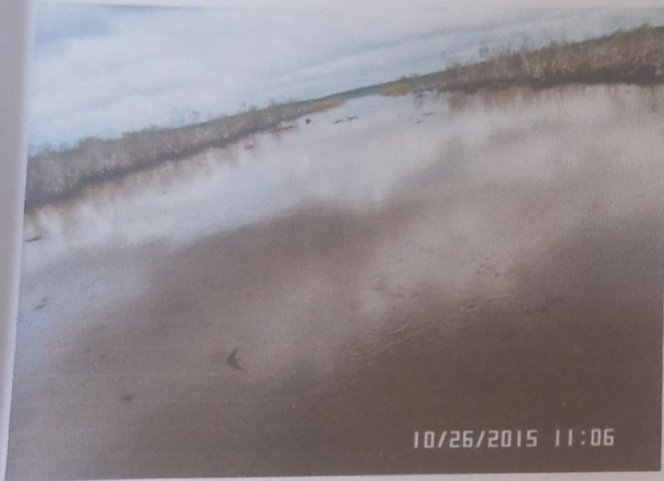
**SPILL POINT BEFORE EXCAVATION**

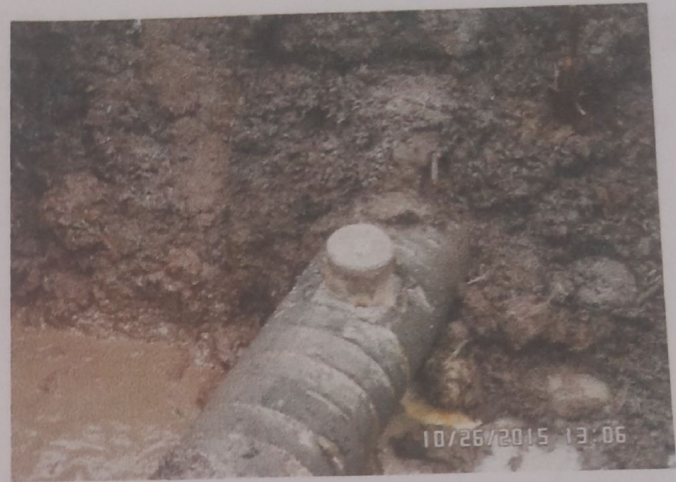
**BUNKERING POINT SHOWN**
