# JOINT INVESTIGATION REPORT

INCIDENT NO: 1486279 JIV report S/N: Nº 0000052

1. Spill incident Number: 1486279 2. Type of incident\* ASSET DAMAGE.  
3. Name of Location DIABU CREEK WELL 13T WELL HEAD.  
4. Name of nearest community PEREMABIRI 5. State: BAYELSA 6. LGA SOUTHERN TIANI  
7. Type of Production facility/Installation WELL HEAD  
8. Asset owner/District SPDC / LAND 2.

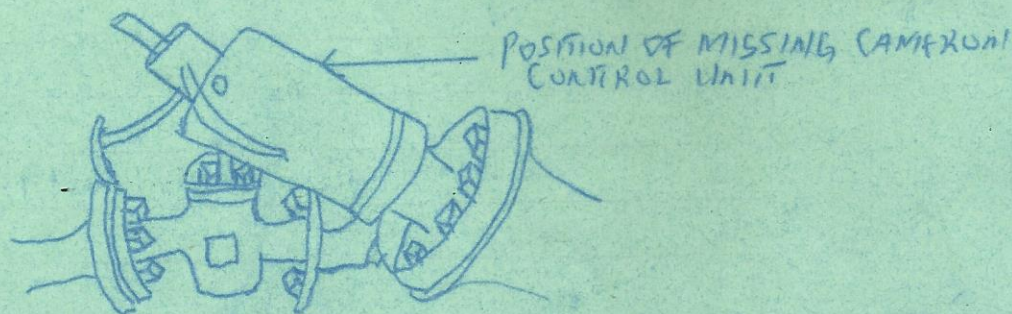
| <input checked="" type="checkbox"/> Others(specify) <u>CAMERON CONTROL UNIT WAS REMOVED BY UNKNOWN PERSON.</u> | | |

SECTION OF DIBBU CRACK WHEEL 1ST WHEELHEAD AT PERIMABIAI SHOWING POSITION OF MISSING CAMERON CONTROL UNIT.

REPAIR WORK PLANNED

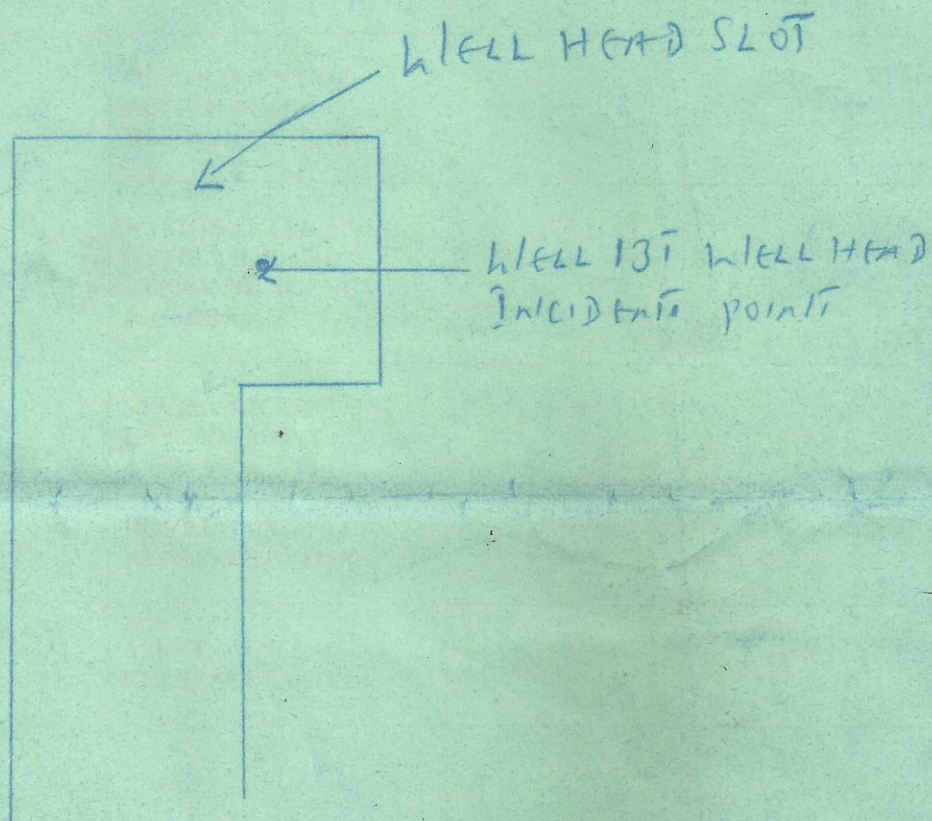
f. Appendix 1: Overview sketch of the site

Location: DABU CREEK W/ELL 13T W/ELL HEAD AT PEREMABIRI
