## PHOTOGRAPHS TAKEN ON SITE

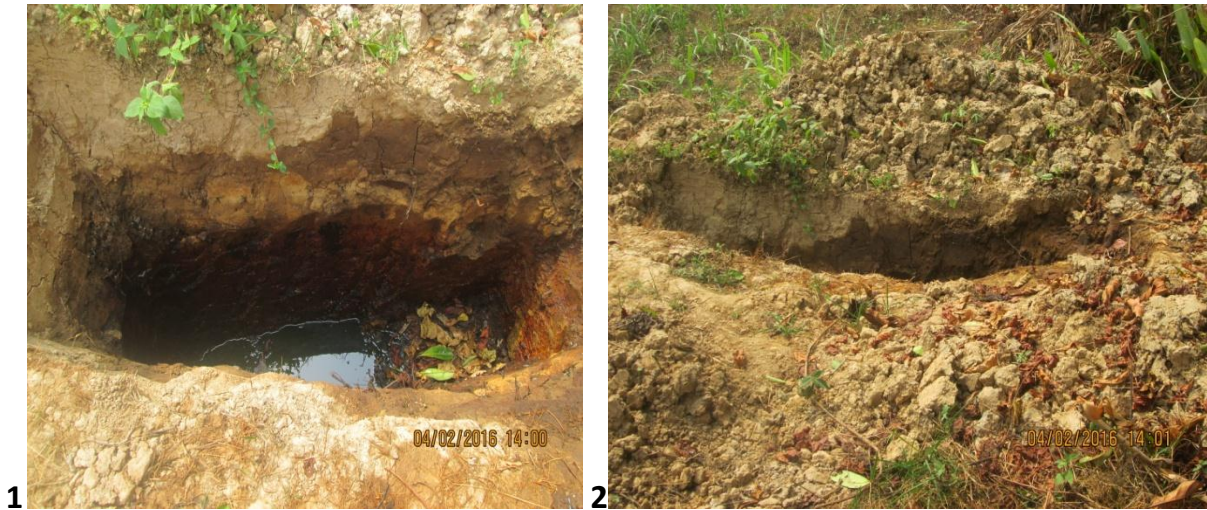
**FIG 1-2: Excavated pit by vandals**

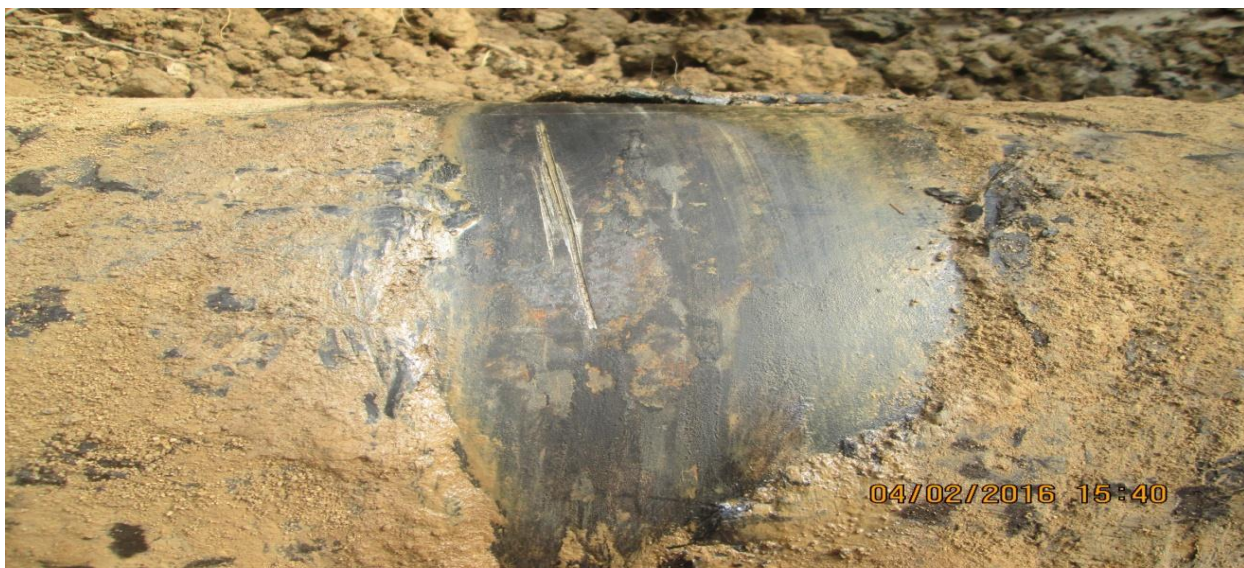
**Fig 4: Spill point (Hack saw cut)**

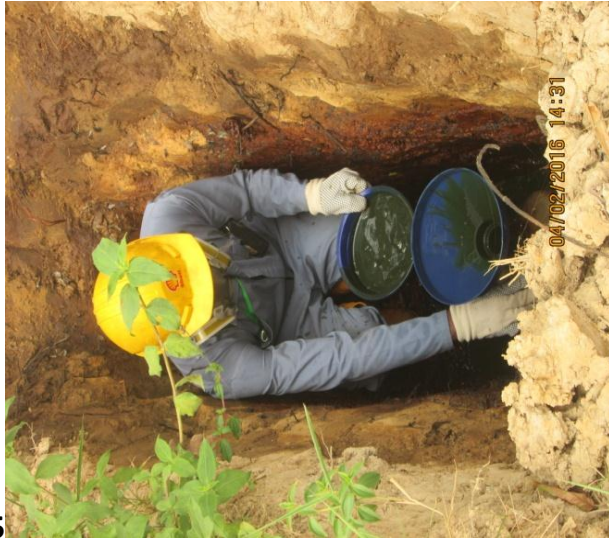
5

FIG. 5: Oil recovery in progress
