**PHOTOGRAPHS TAKEN ON SITE: 10' CLOUGH CREEK/TEBIDABA PIPELINE AT AZAGBENE**

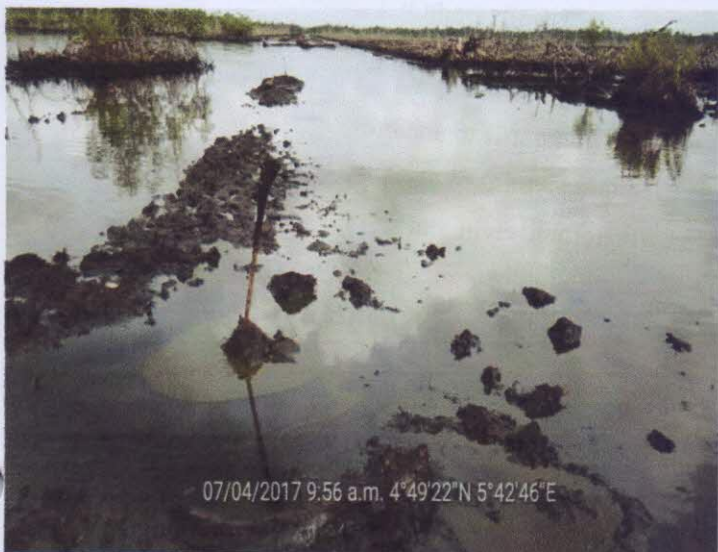
**A: SITE PONT ARRIVAL**

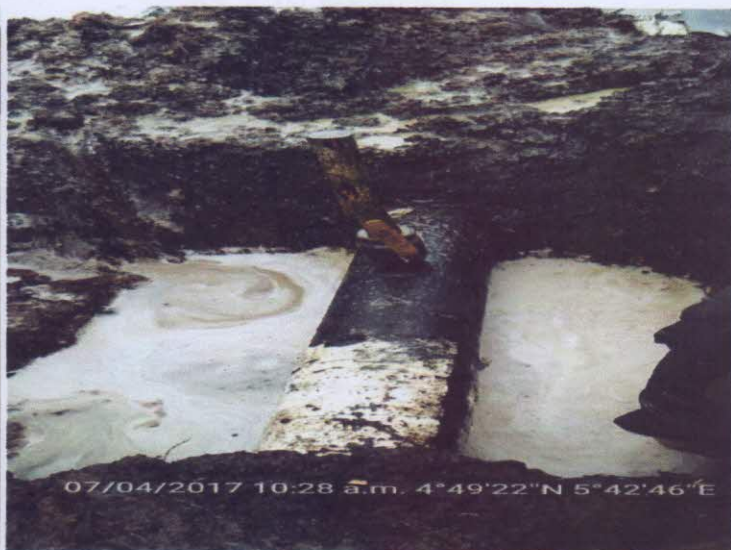
**B: LEAK POINT AFTER OPENING AND PEGGING**

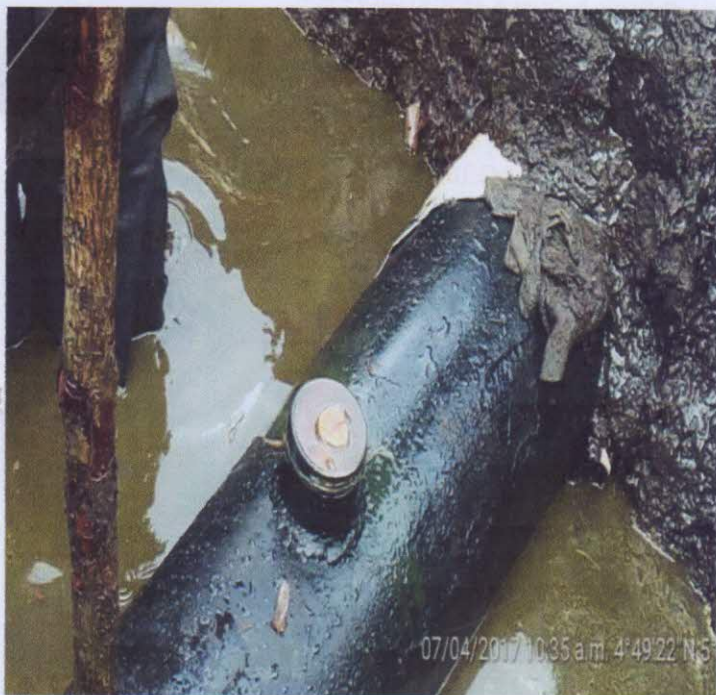
**C: CONING OF LEAK POINT**

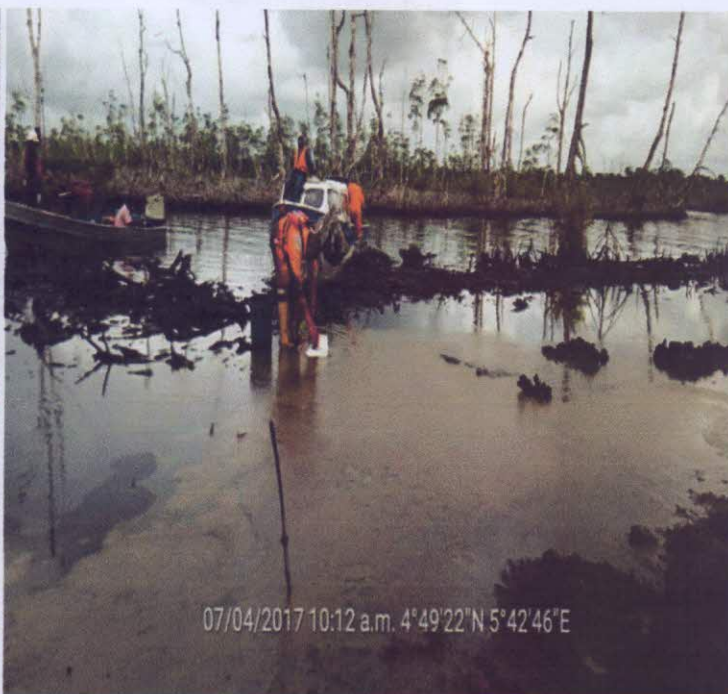
**D: CRUDE RECOVERY ON SITE**
