# SOME PHOTOGRAPHS TAKEN DURING THE JOINT INVESTIGATION VISIT (JIV)

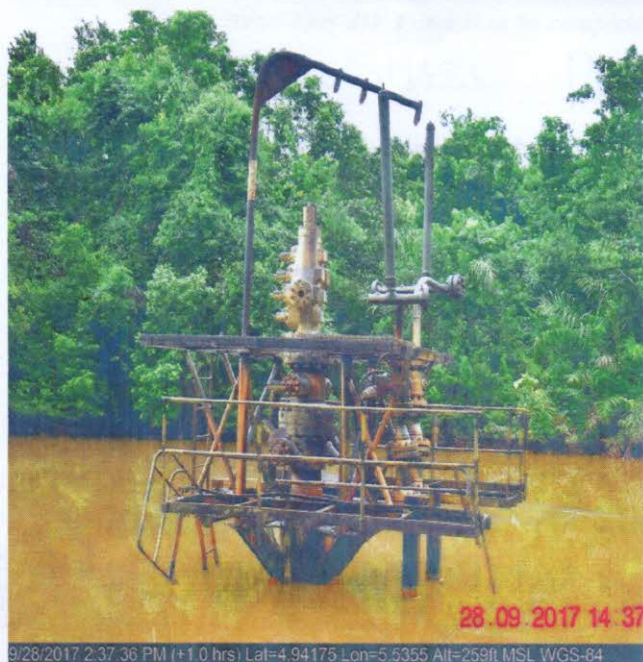
Fig A: Incident Facility (Agbaya Well 1 Wellhead)

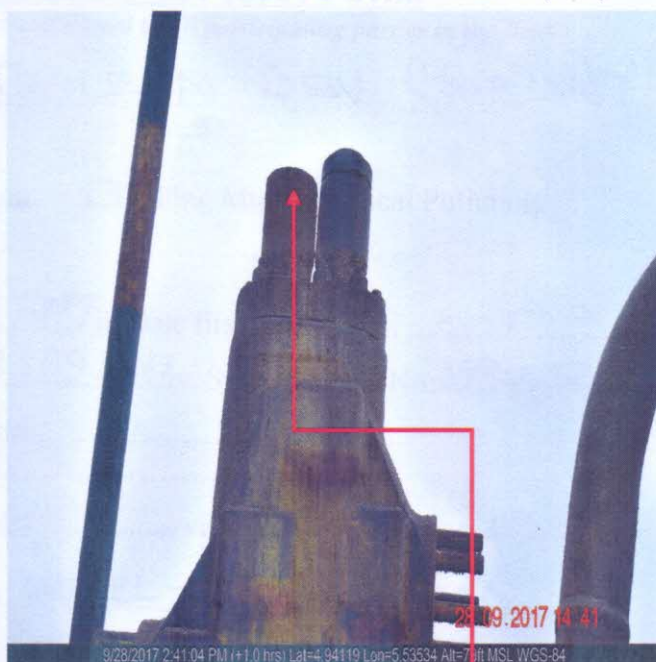
Fig B: Position of stolen survey cap

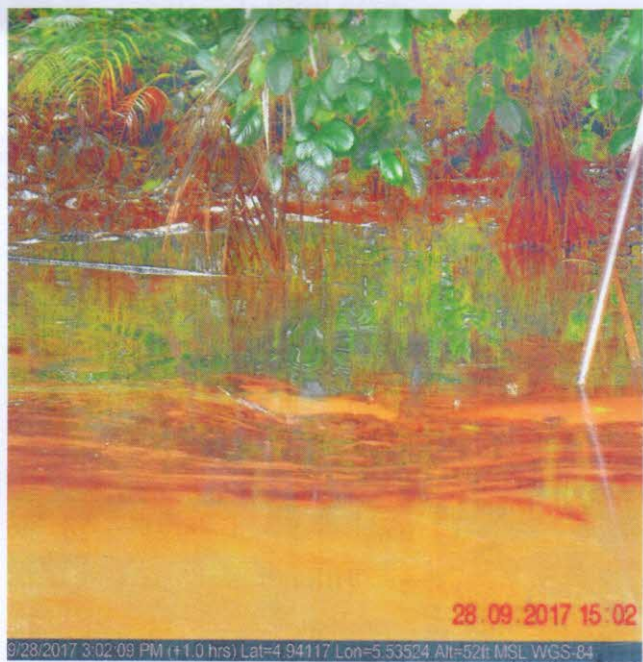
Fig C: Oil Spill impacted area

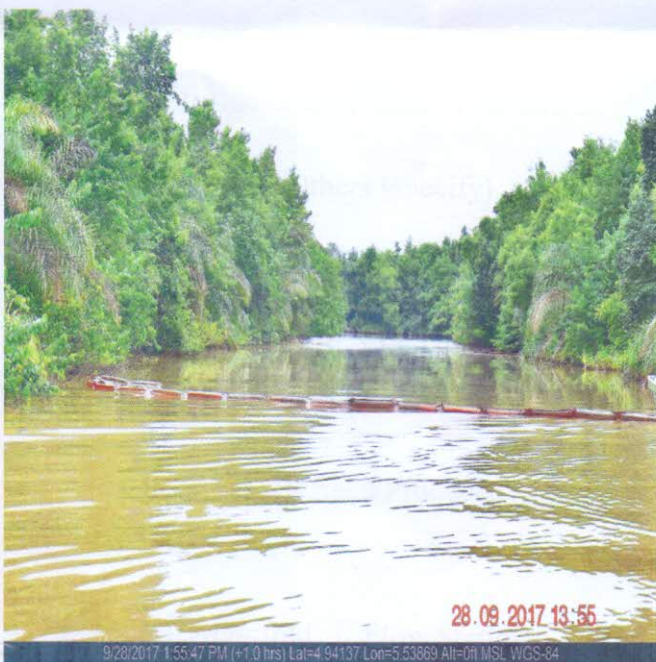
Fig D: Containment boom(s) on SPDC's RoW.
