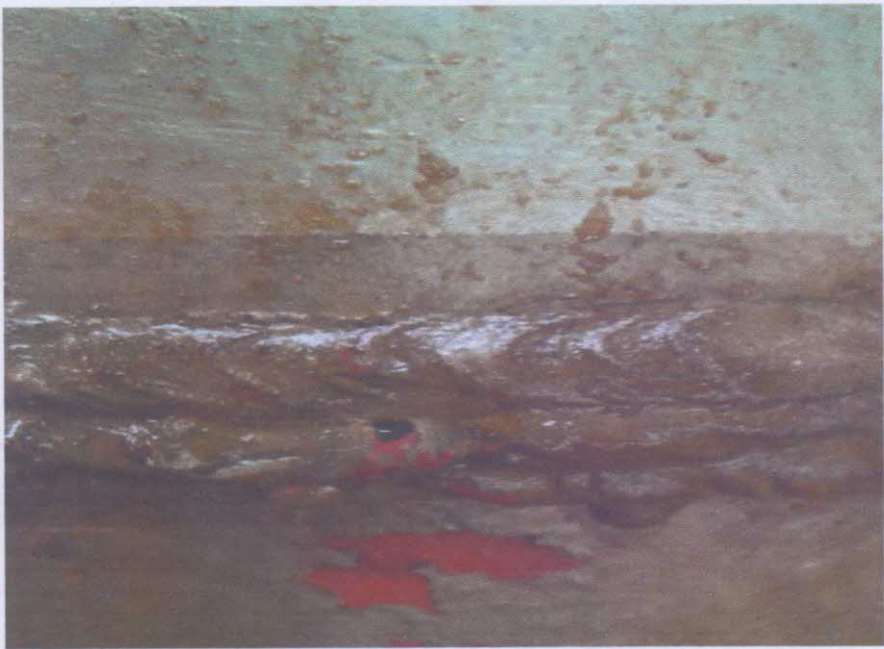
Picture showing pinhole on the wellhead.

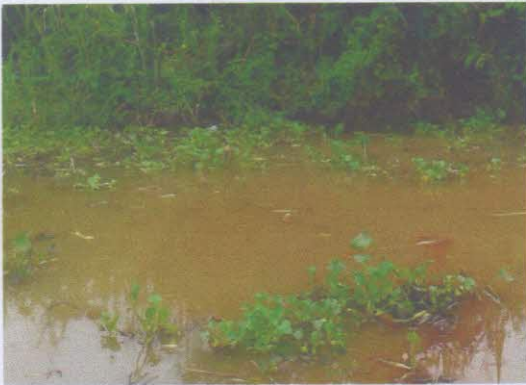
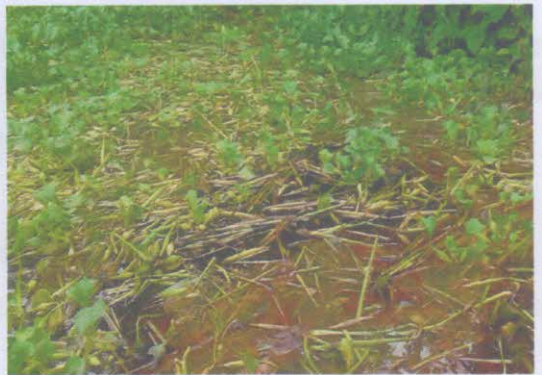
Picture showing some of the impacted areas within the well slot.
