## SOME PHOTOGRAPHS TAKEN DURING THE JOINT INVESTIGATION VISIT

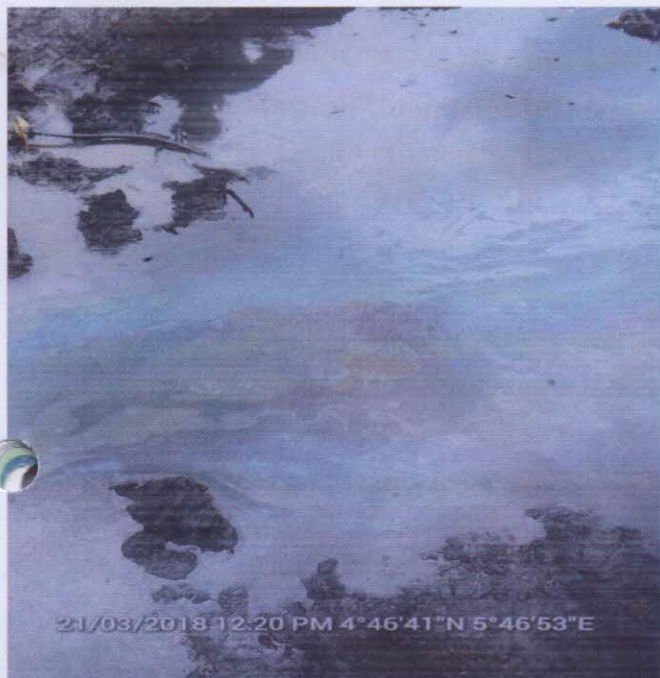
Fig A: Incident Area on arrival of the JIT

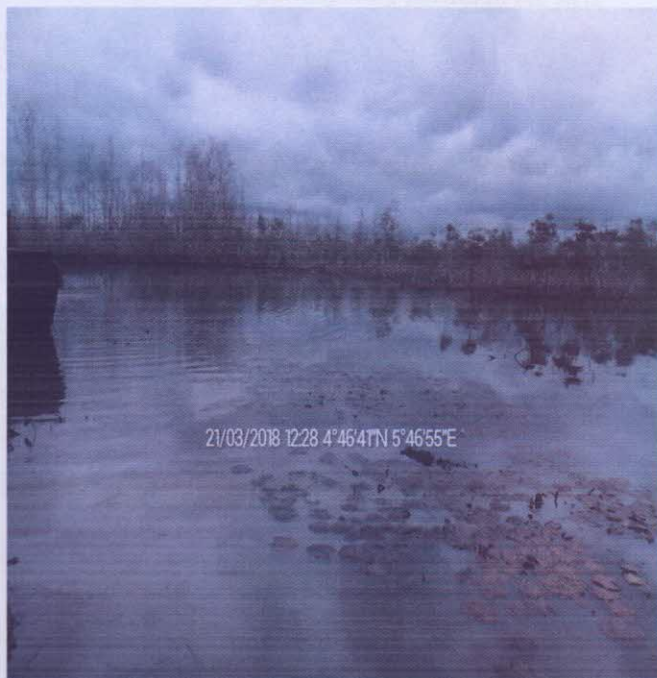
Fig B: Adjoining environment/oil stained vegetation

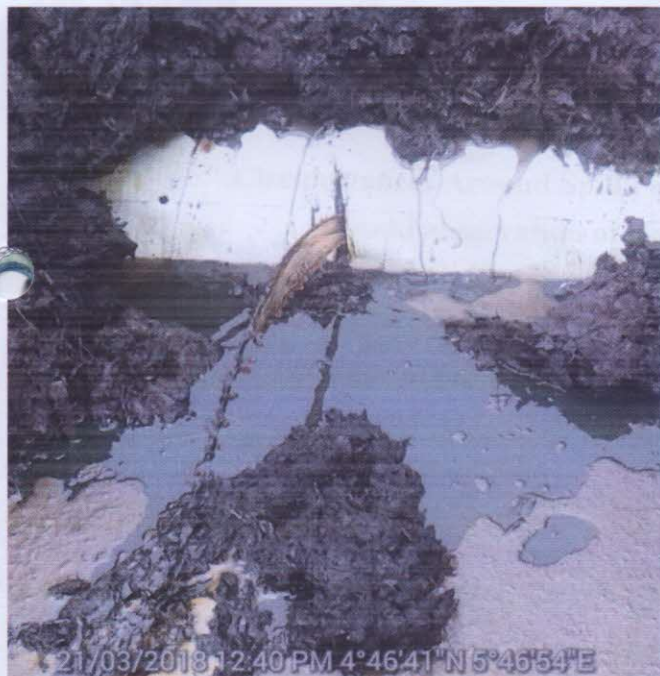
Fig C: Incident Facility after excavation

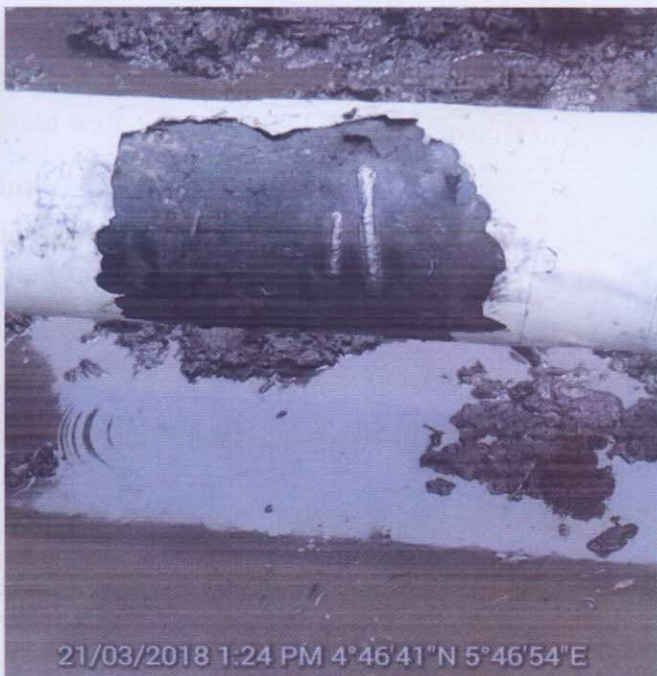
Fig D: Incident facility during repair
