## SOME PHOTOGRAPHS TAKEN DURING THE JOINT INVESTIGATION VISIT

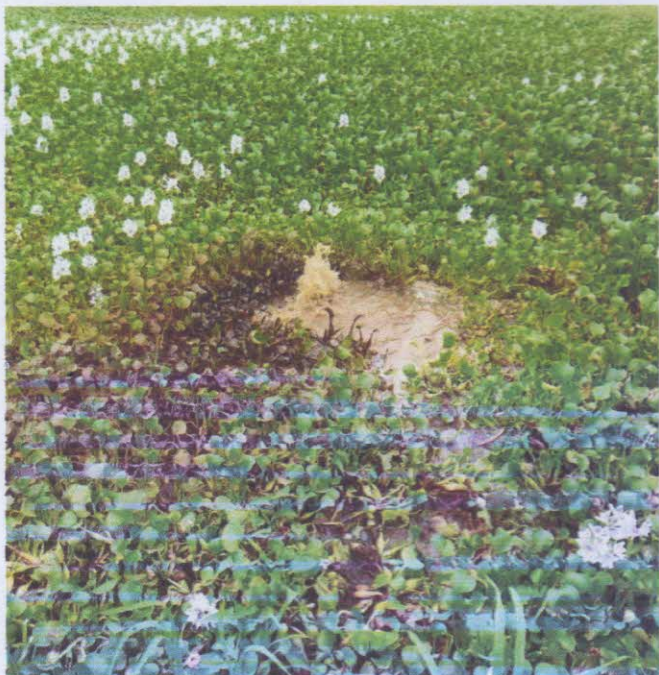
**Fig A: Incident Area on arrival of the JIT**

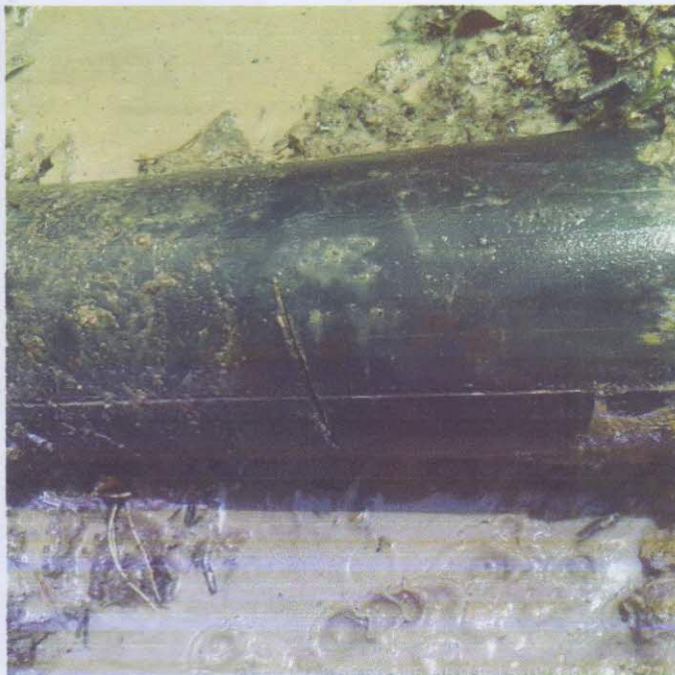
**Fig B: Incident Facility after excavation**

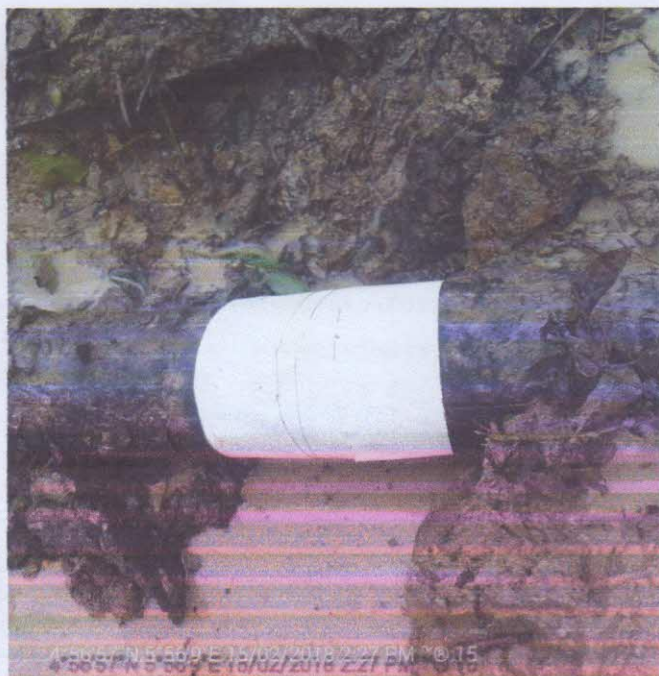
**Fig C: Incident facility shortly after repair**

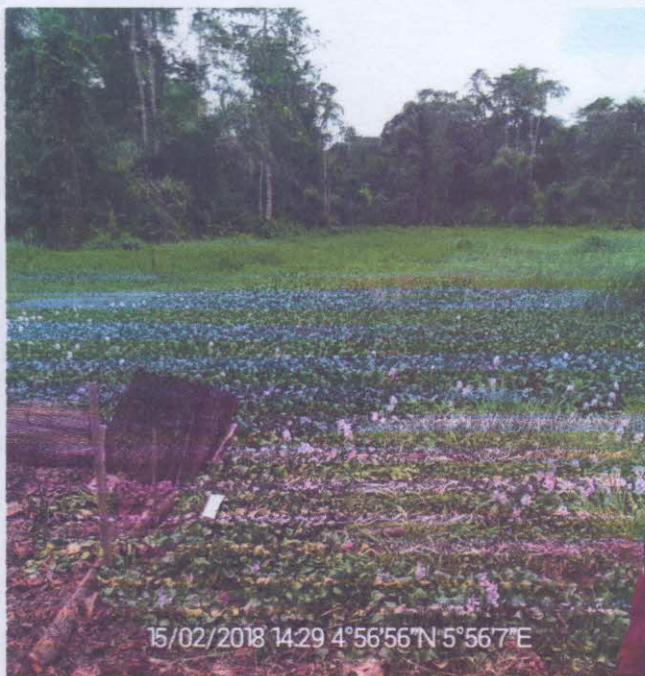
**Fig D: Surrounding Environment/NAOC's RoW**
