3. PICTURES TAKEN AT SITE:

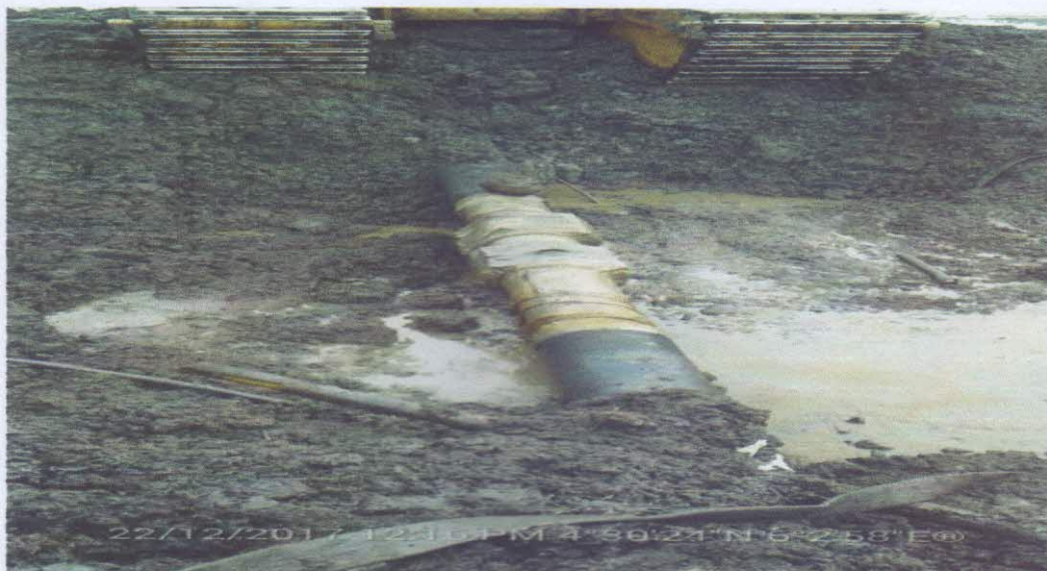
SPILL POINT AFTER EXCAVATION: fig1

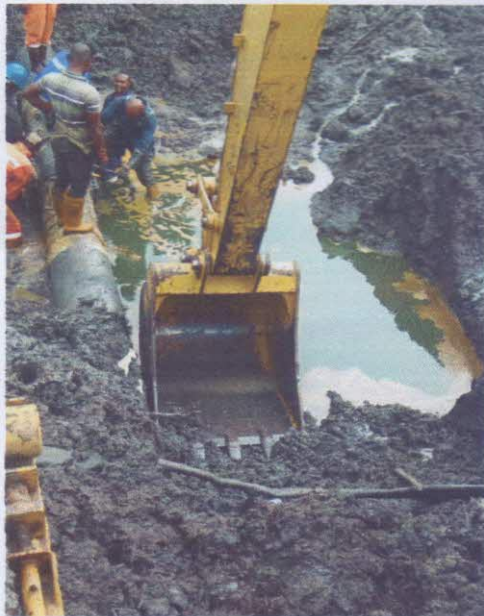
SPILL DURING REPAIR: fig2

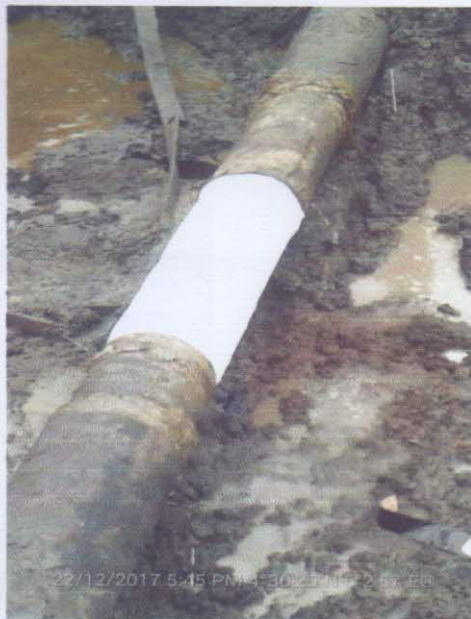
SPILL POINT AFTER REPAIRS: fig3
