## 5. PICTORAL EVIDENCE:

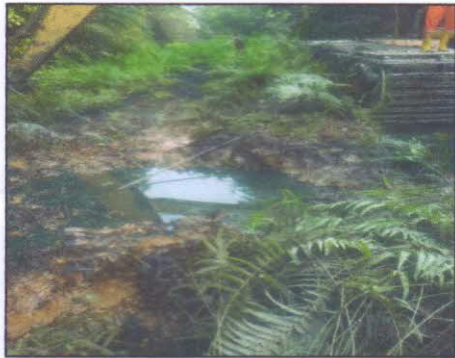
Spill point before excavation

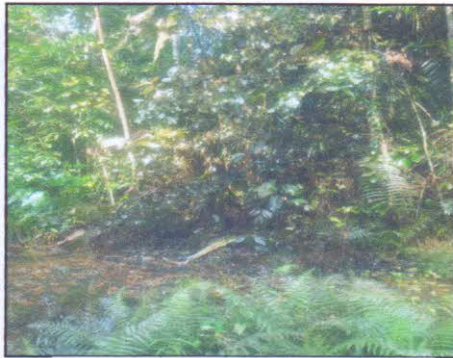
Impacted vegetation

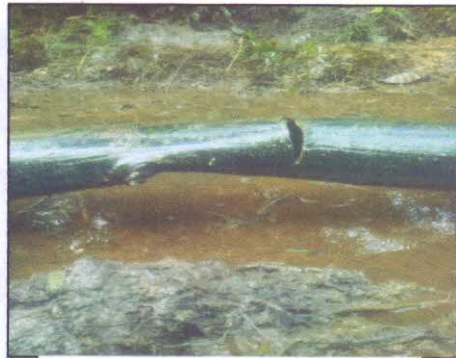
Affected section of facility
