## SOME PHOTOGRAPHS TAKEN DURING THE JOINT INVESTIGATION VISIT

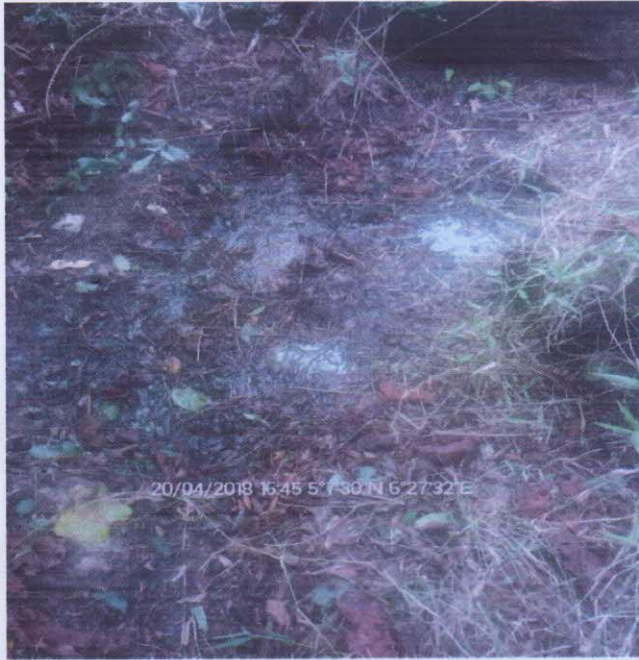
Fig A: Incident Area on arrival of the JIT

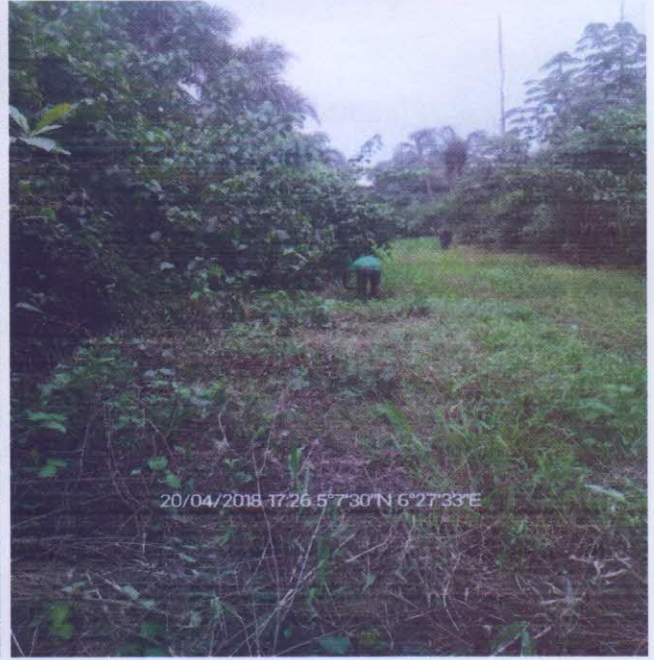
Fig B: Adjoining vegetation/RoW

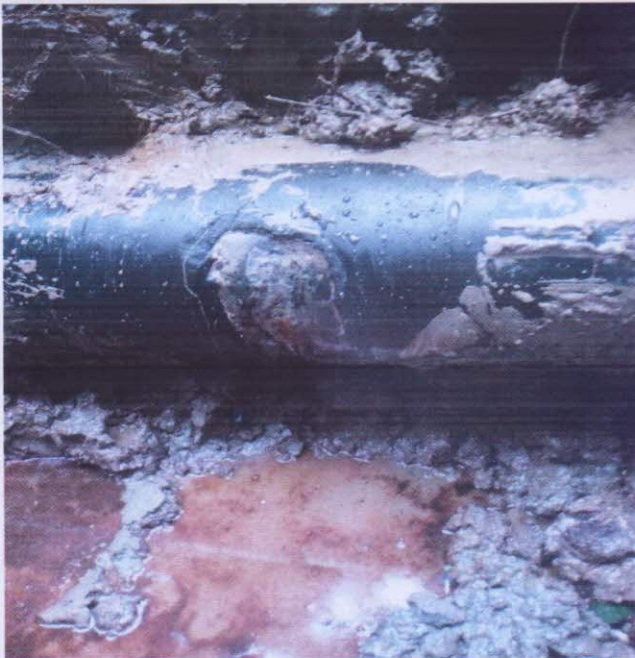
Fig C: The Leak Point after excavation

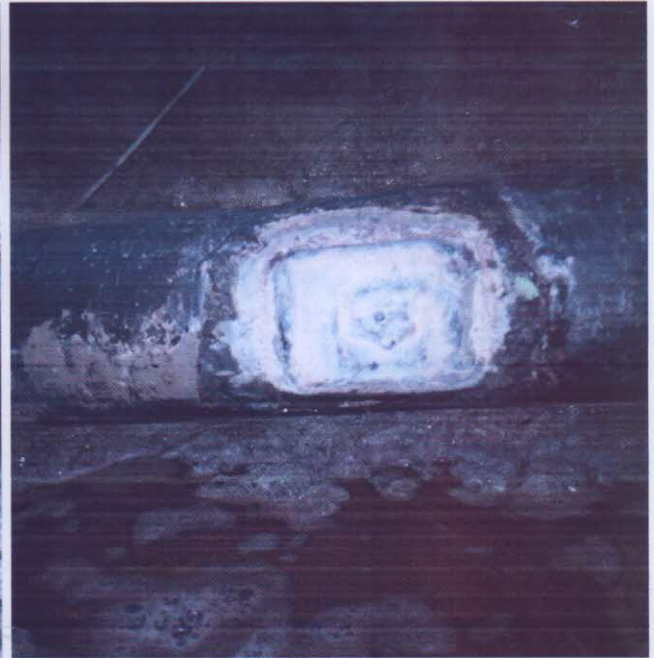
Fig D: Incident facility during repair
