## PHOTOGRAPH TAKEN DURING JIV

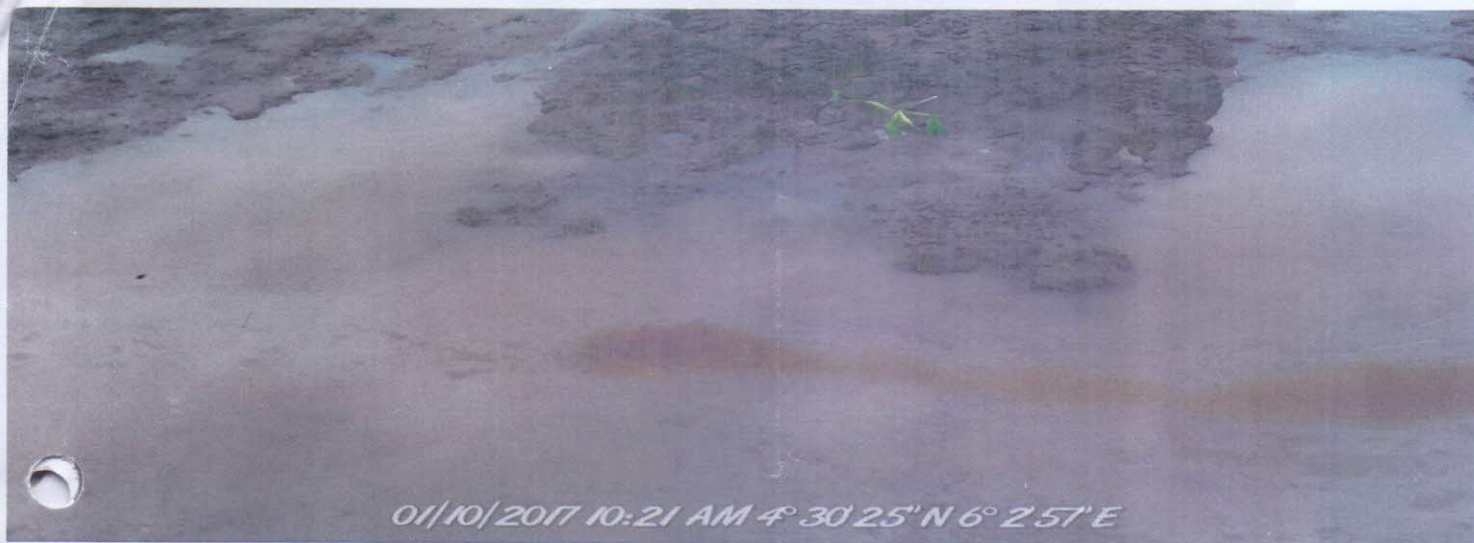
AN AREA VIEW OF THE SPILL POINT BEFORE EXCAVATION.

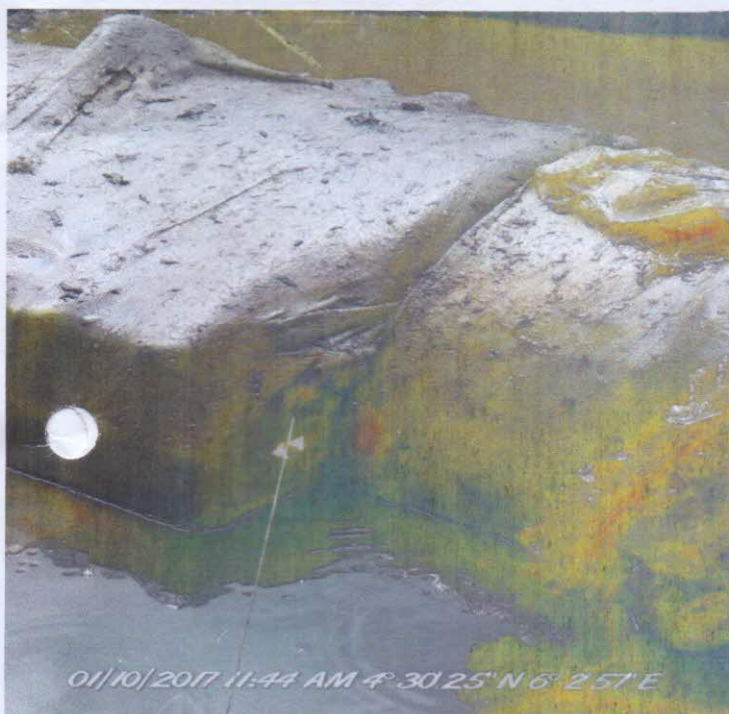
Figure 2 SOURCE OF THE LEAKAGE FROM THE FAILED CLAMP (2) AFTER EXCAVATION.

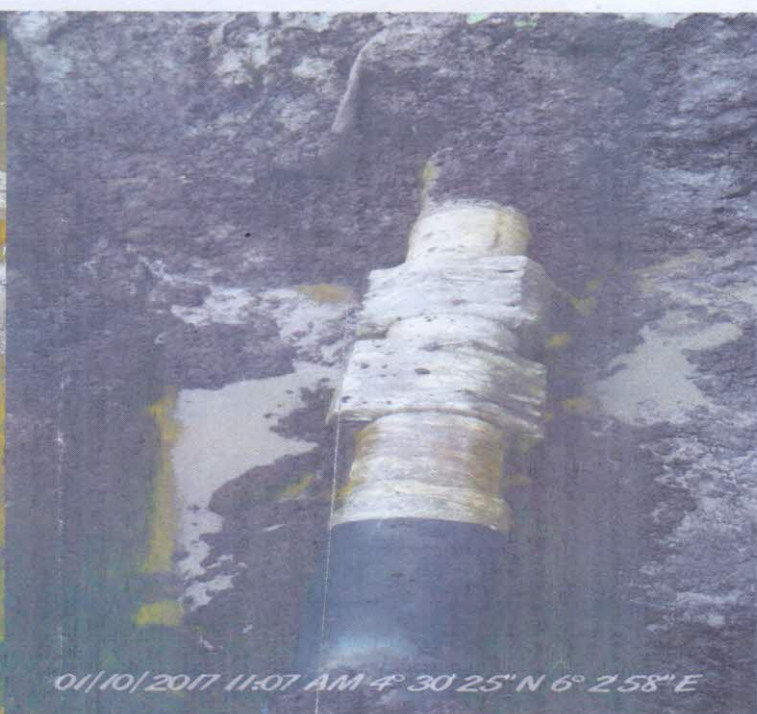
Figure 1 TWO CLAMPS SECTIONED ON THE AFFECTED PIPE LINE (1&2) AFTER EXCAVATION.

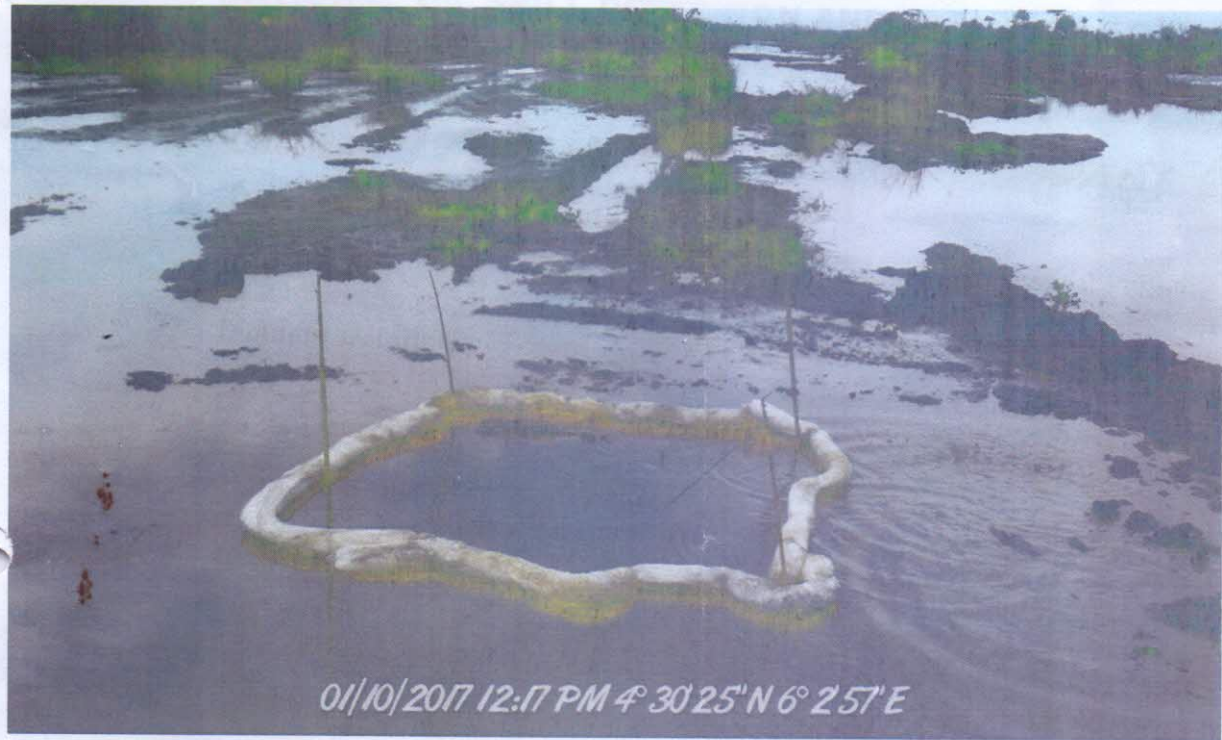
The spill point backfilled and boom used as structural control in place.
