## PHOTOGRAPHS TAKEN ON SITE

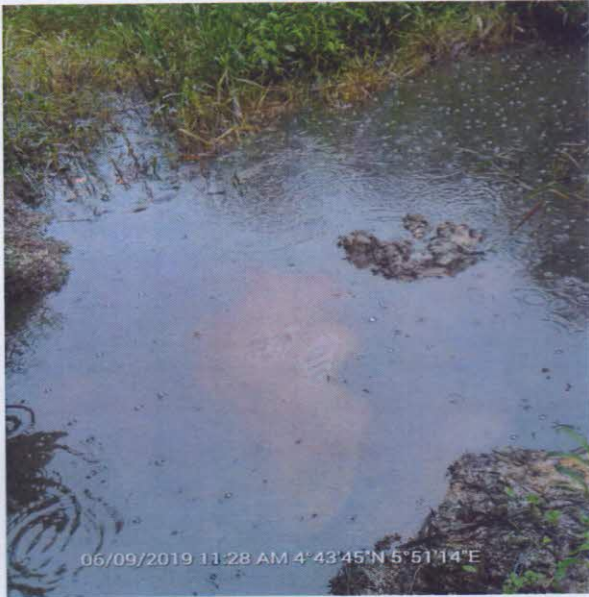
**FIG A: Incident point on arrival**

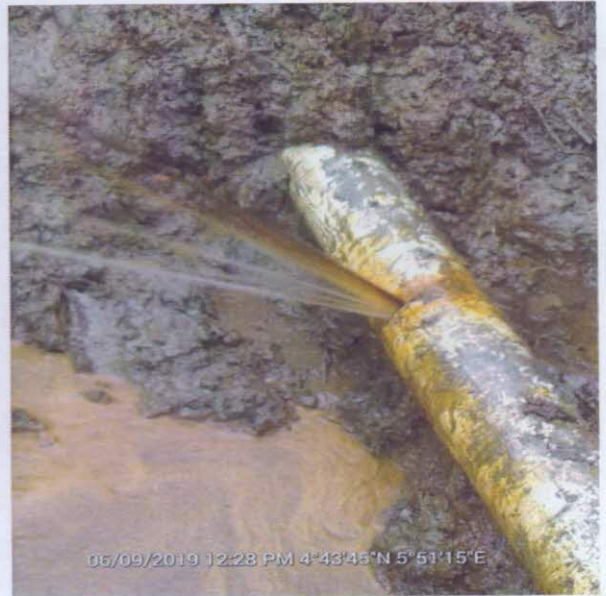
**FIG B: Incident point on exposure**
