## PHOTOGRAPHS TAKEN ON SITE

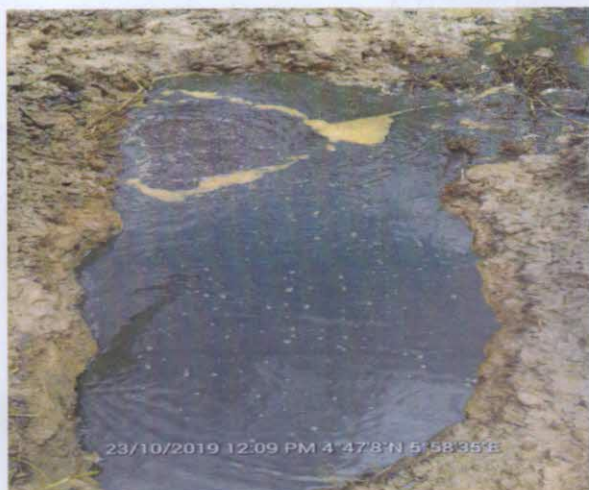
**FIG A: Incident point on arrival**

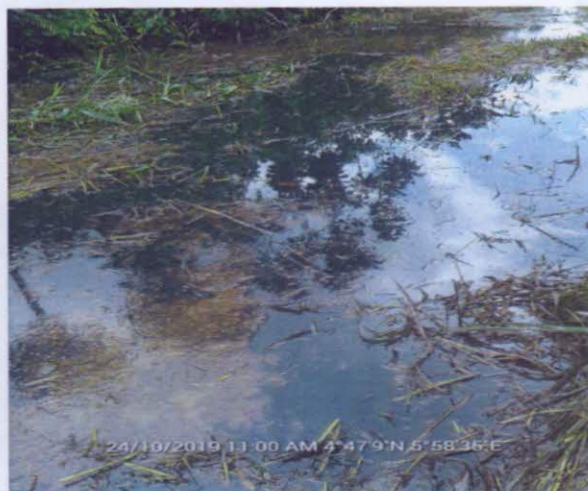
**FIG B: Impacted environment**

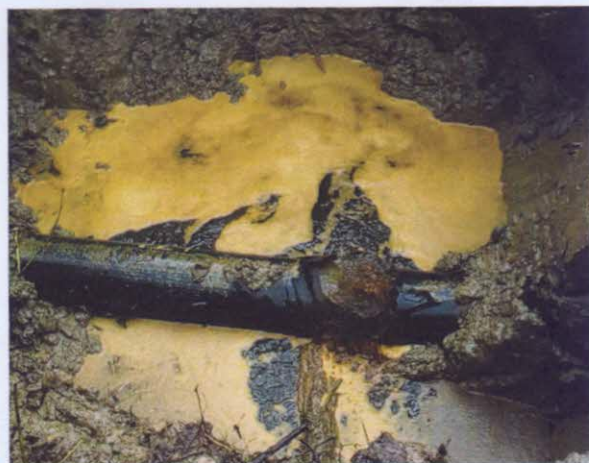
**FIG C -D: Incident point on exposure**
