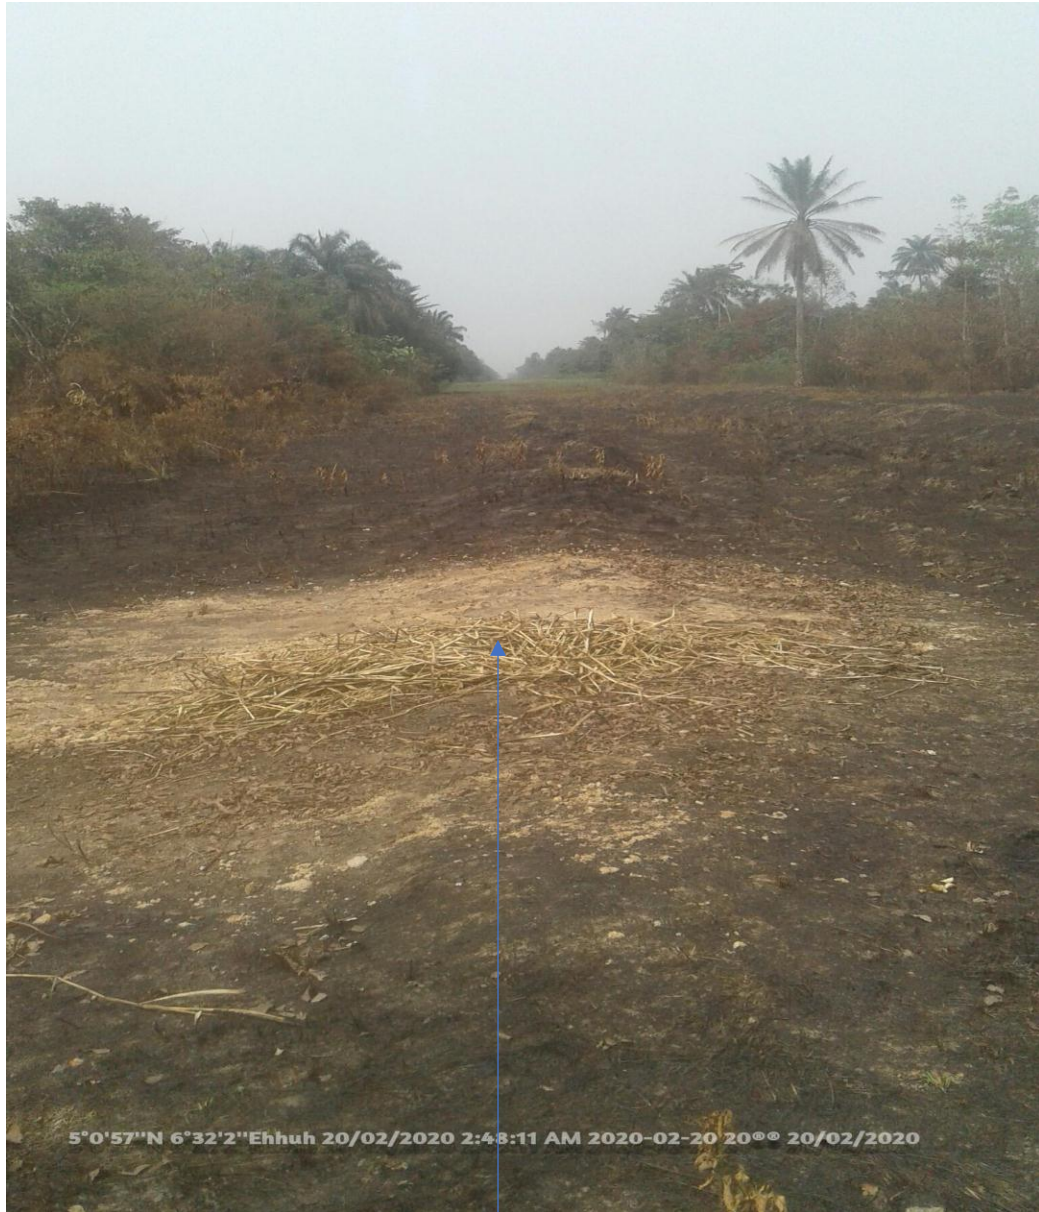
PIC: SHOWING INCIDENT POINT BEFORE EXCAVATION (NON-LEAK POINT)

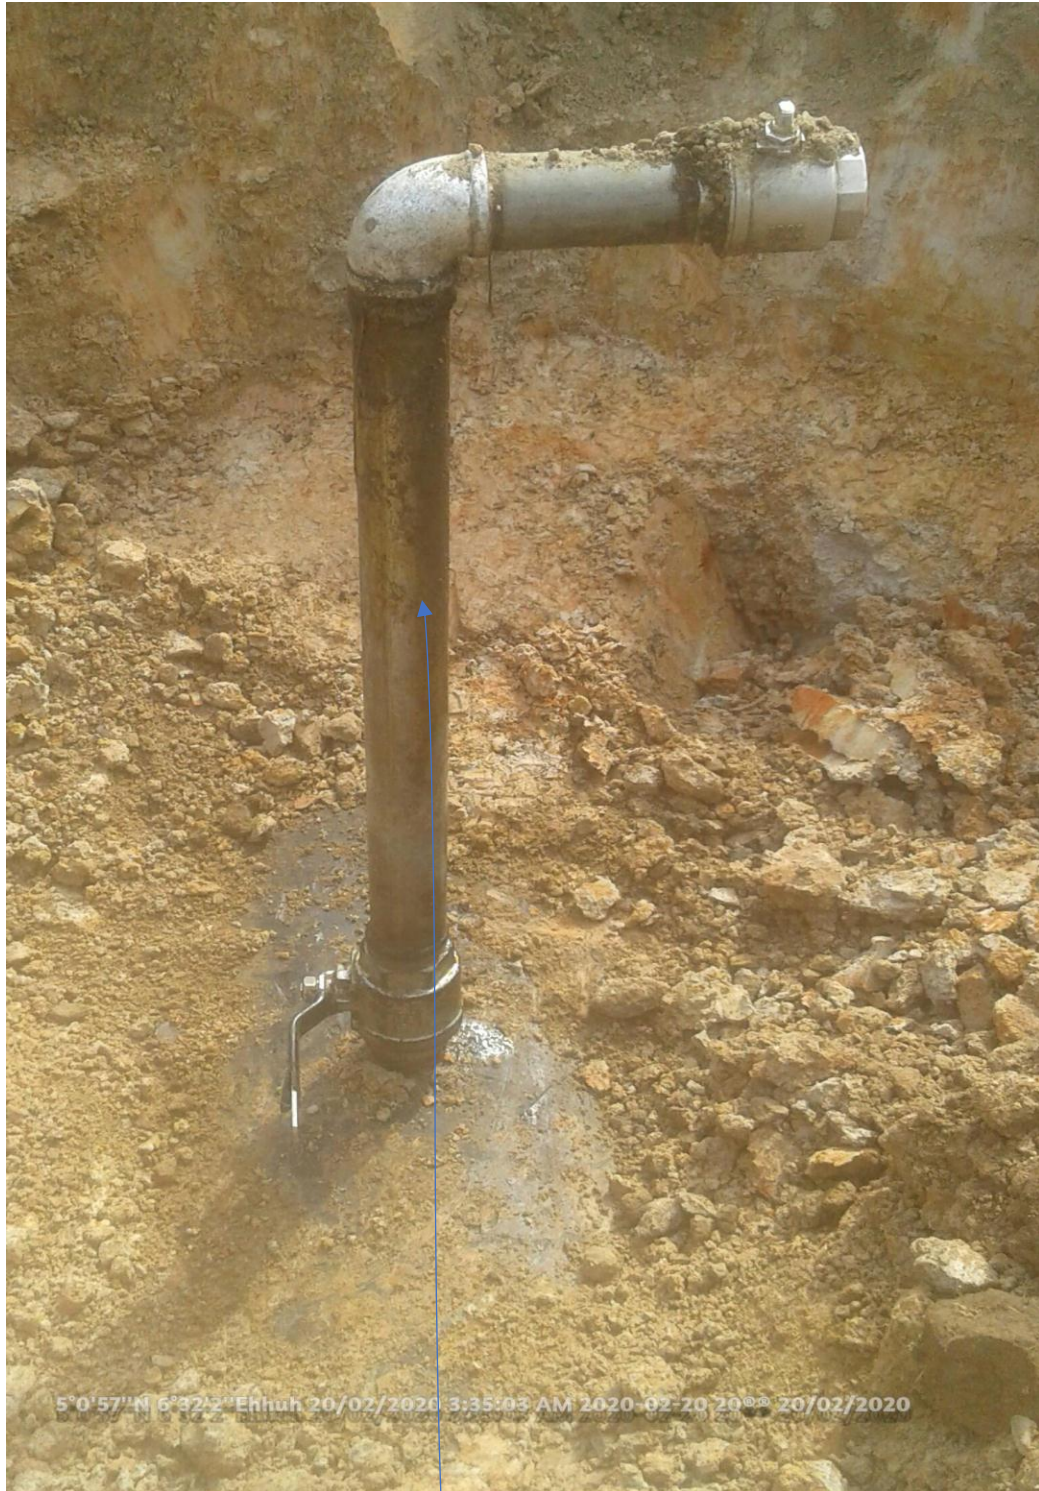
PIC: SHOWING POINT AFTER EXPOSURE (2" BALL VALVE AND 2 CALVANIZED PIPE WITH ELBOW AT 12'O  
CLOCK POSITION ON THE PIPELINE)
