## PICTURES TAKEN DURING THE JOINT INVESTIGATION VISIT

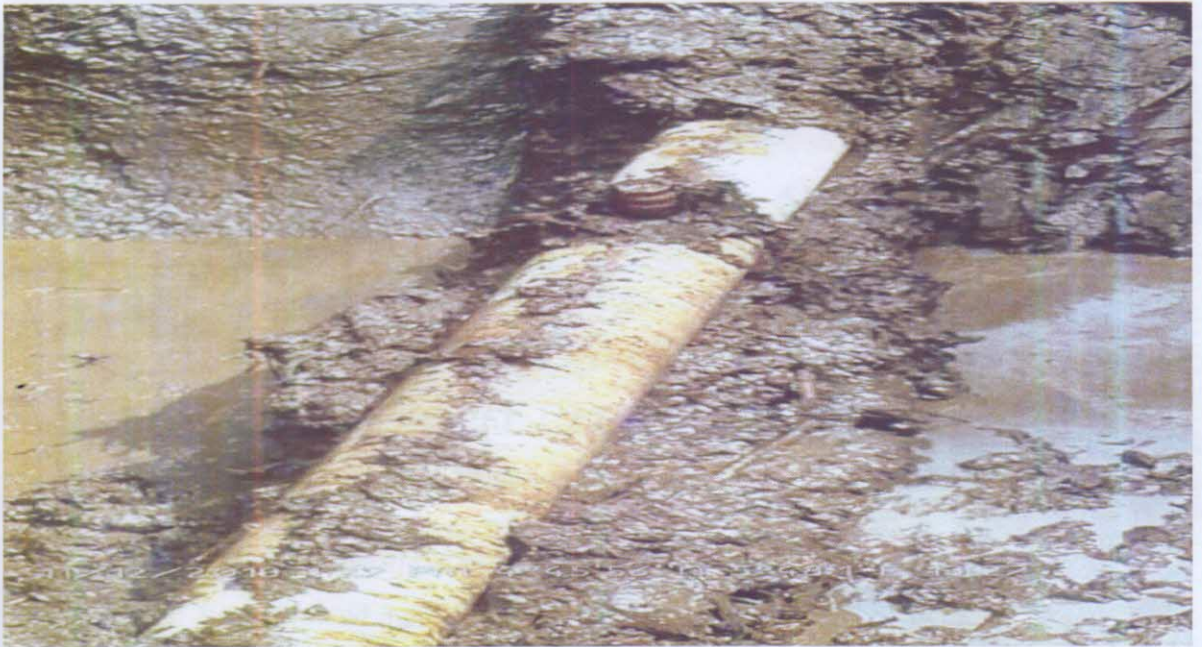
FIG. 1: SHOWING THE INSTALLED 2" VALVE BEFORE REPAIR WORK

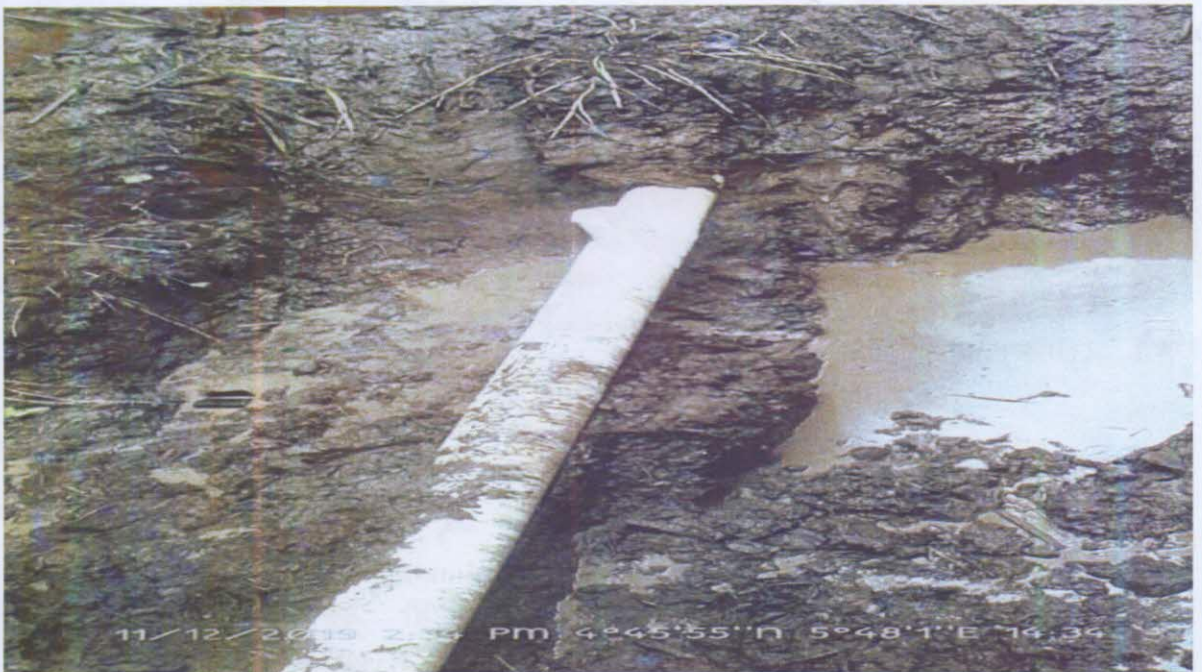
FIG.2: SHOWING THE PIPELINE AFTER REPAIRS
