PHOTOGRAPHS TAKEN DURING THE JOINT INSPECTION VISIT

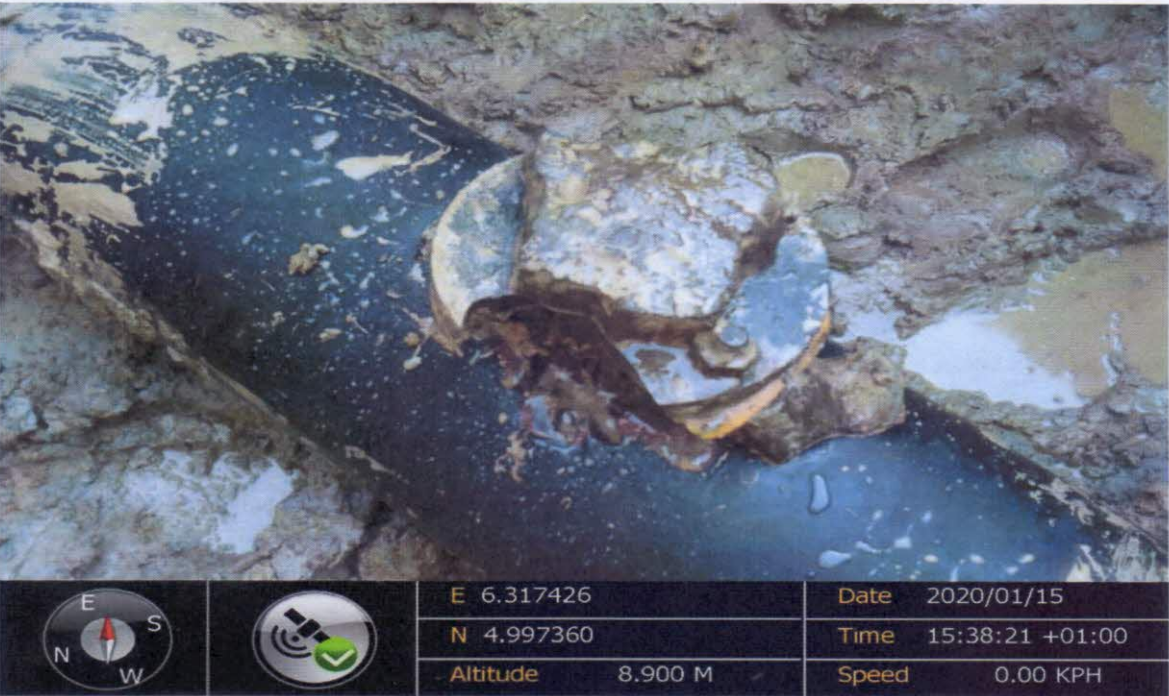
FIG. A: SHOWING A 3” FLANGE INSTALLED AT 12 O’ CLOCK POSITION OF THE PIPELINE

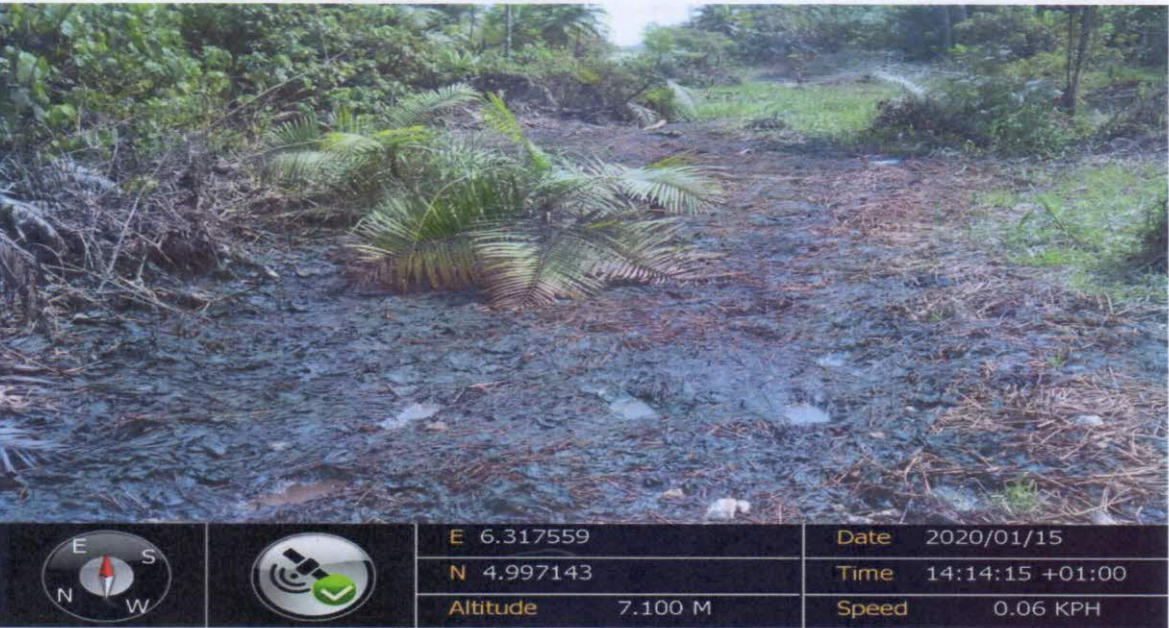
FIG B: SHOWING CRUDE STAINED AND WEATHERED VEGETATION AT THE IMPACTED AREA
