## PHOTOGRAPHS TAKEN DURING THE JIV AT ETELEBOU FLOW STATION

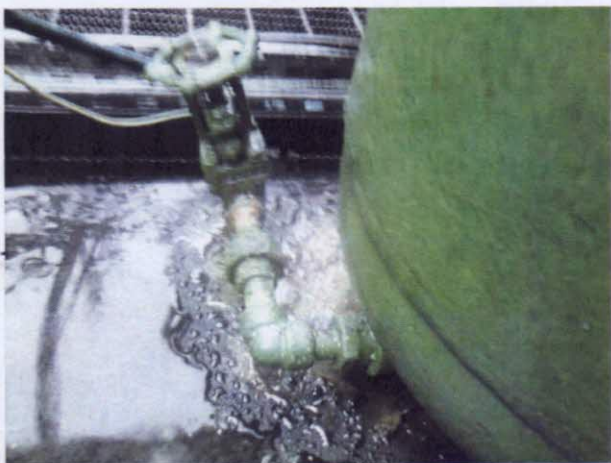
**FIG. A: THREE QUARTER PIPE THAT SPILLED OIL**

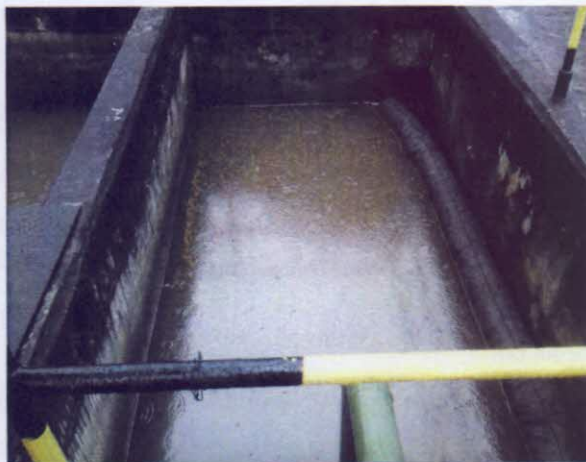
**FIG. B: THE SERVER PIT ROM WHERE OIL ESCAPED**

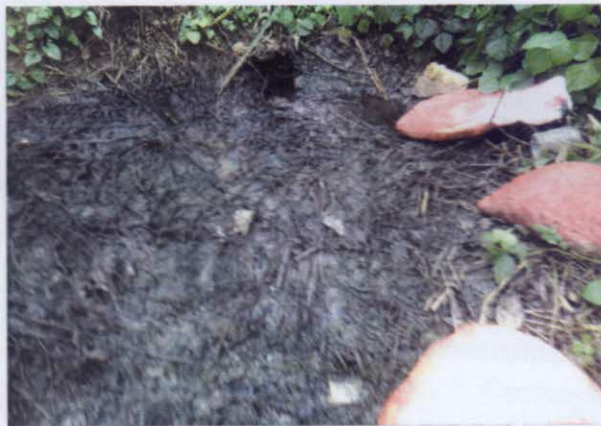
**FIG. C: TREATED WATER DISCHARGE PIPE OPENING**

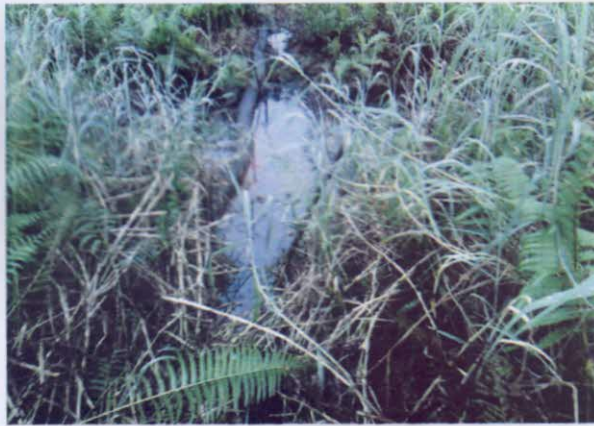
**FIG. D: VEGETATION IMPACTED BY CRUDE OIL**

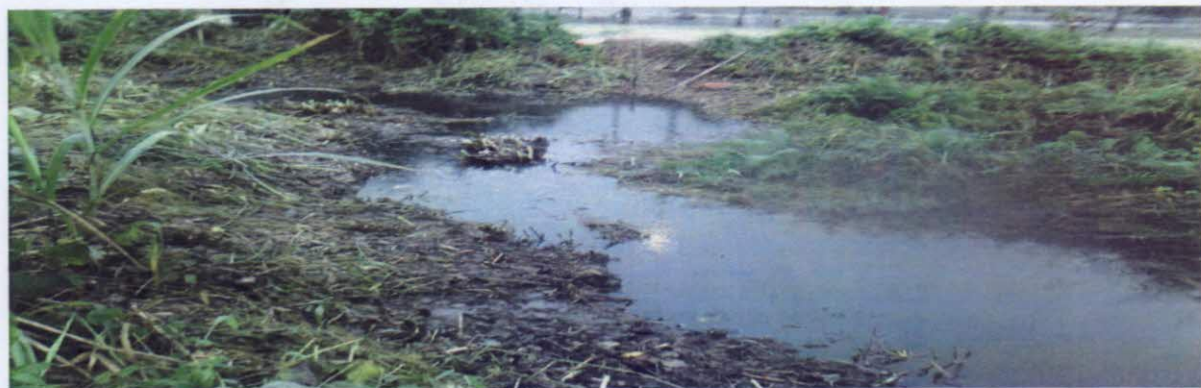
**FIG. E: STRECH OF WATER AND LAND IMPACTED BY CRUDE OIL**
