# SOME PHOTOGRAPHS TAKEN DURING THE JOINT INVESTIGATION VISIT (JIV)

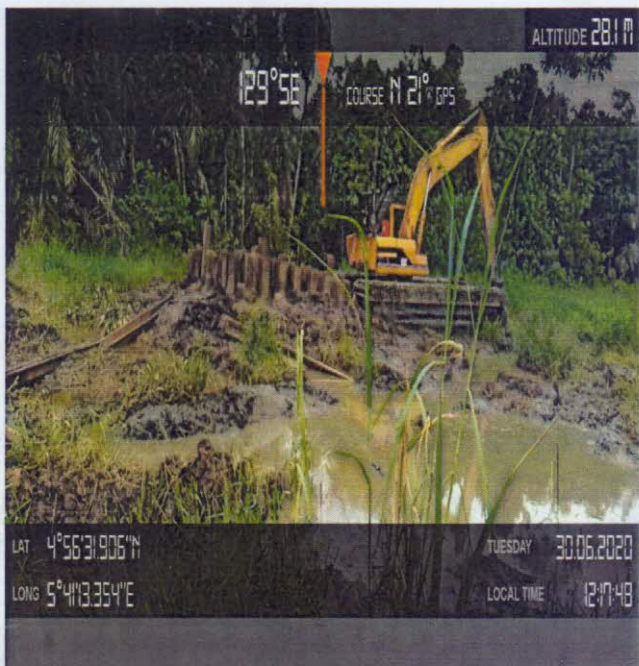
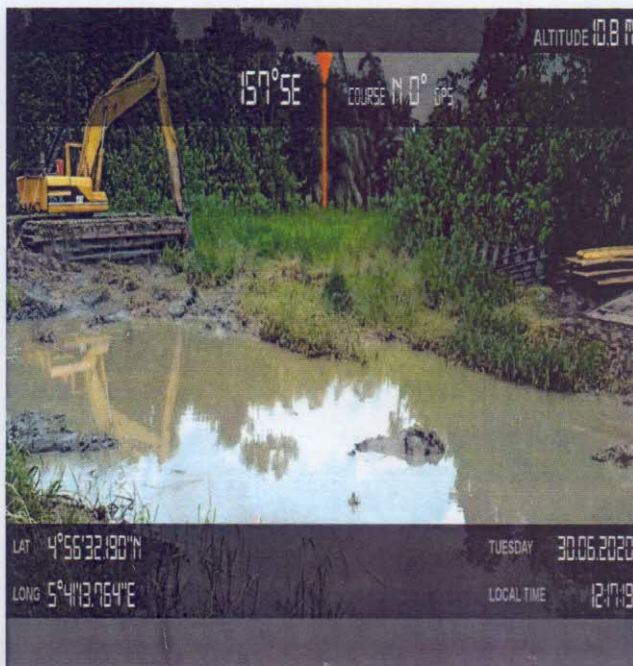
Fig A & B: Incident Area on arrival of the JIT and green vegetation

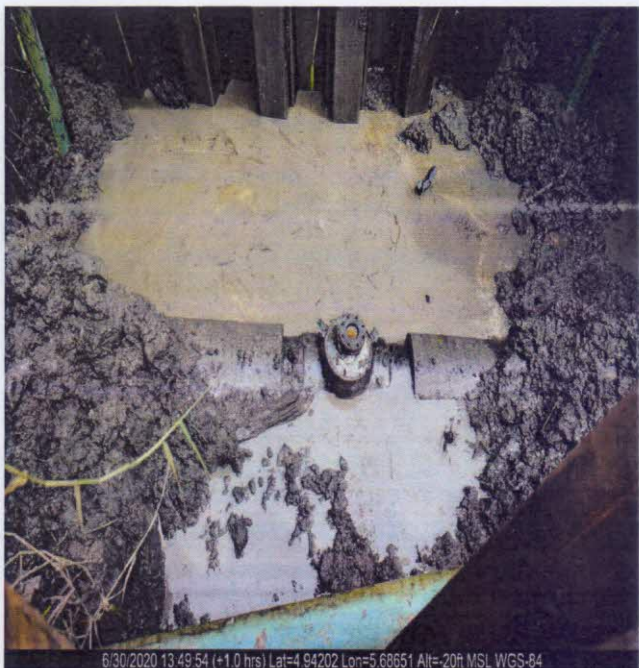
Fig C: Incident facility after exposure

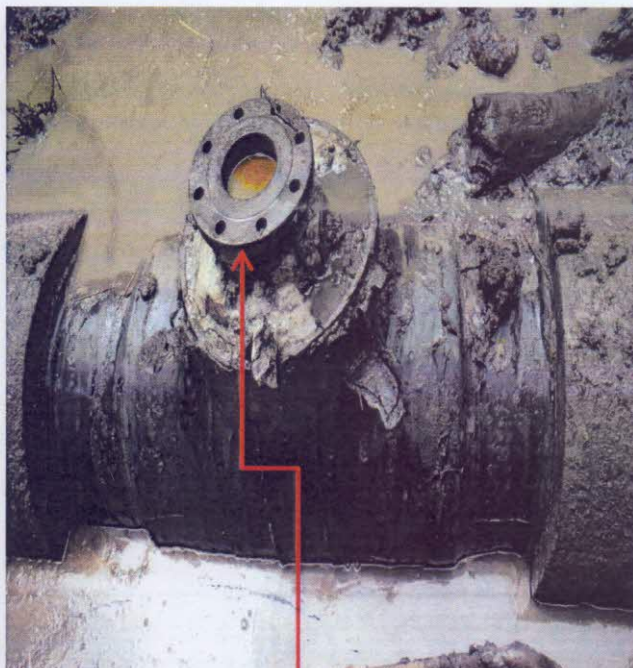
Fig D: 4" nipple/valve installed by Vandals
