**BRIEF ON JOINT INVESTIGATION VISIT (JIV) AT IJEGUN IMORE, SATELLITE TOWN, AMUWO-ODOFIN LOCAL GOVERNMENT AREA OF LAGOS STATE ON THE 9<sup>TH</sup> OF APRIL, 2020**

**1. COMPANY ADDRESS/FACILITY DETAILS**

Satellite Town, Amuwo-Odofin Local Government Area, Lagos

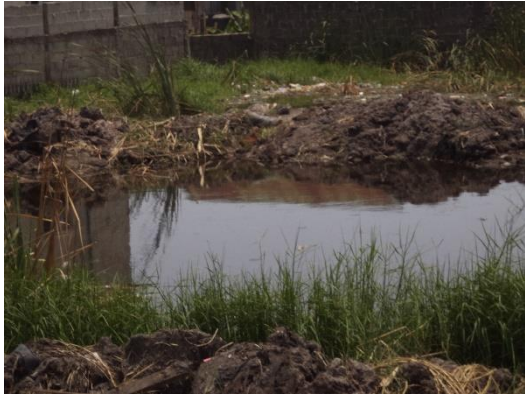
- a. The seepage was most likely triggered by the Abule Ado explosion.
- b. The line had been repaired
- c. NPSC Atlas Cove is in charge of that axis
- d. The community has a history of pipeline vandalization
- e. Hydrostatic test was conducted and pumping of product through the affected pipeline has resumed.

Pic 1: location of repaired Pipeline

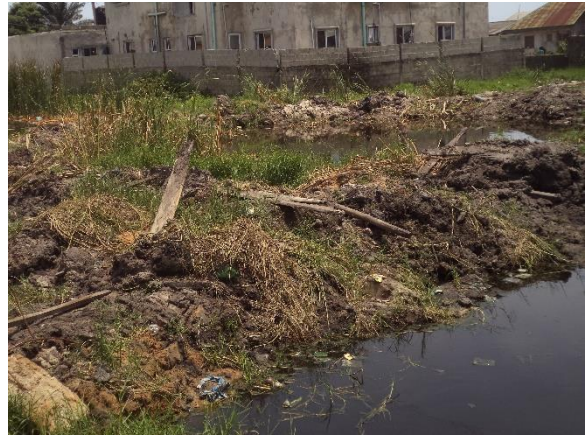
- a) The atmosphere within the incident area was no longer pungent with petroleum product fumes and there was no sheen on the surface of the swamp
- b) The incident occurred on NPSC Right of Way
- c) Product pumped through the pipeline is Premium Motor Spirit (PMS)
- d) No effective security surveillance/patrol observed
- e) The area along the Right of way was cluttered with debris
- f) The spill occurred in a swampy area and as a result the affected pipeline was not visible

Pic 2: Debris around the right of way

- a. Properly delineate the Pipeline right of way
- b. Provide effective security to monitor activities around the pipeline and the community.
- c. Be directed to collaborate with other stakeholders in sensitization of the community as well as all pipeline host communities on the dangers of pipeline vandalism.

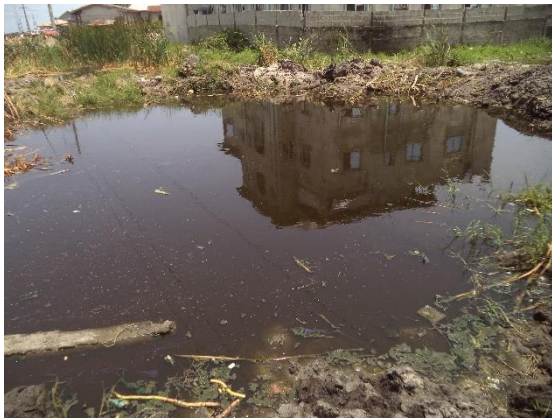
Pic 3: Swamp where pipeline is situated
